# Island Park Village

## Level 1 Reserve Study

**Report Period – 10/01/2013 – 9/30/2014**

<b>Date of Property Inspection</b>	<b>5/21/2013</b>
<b>Prepared By</b>	<b>Dale Gifford</b>
<b>Analysis Method</b>	<b>Cash Flow</b>
<b>Funding Goal</b>	<b>Full Funding</b>

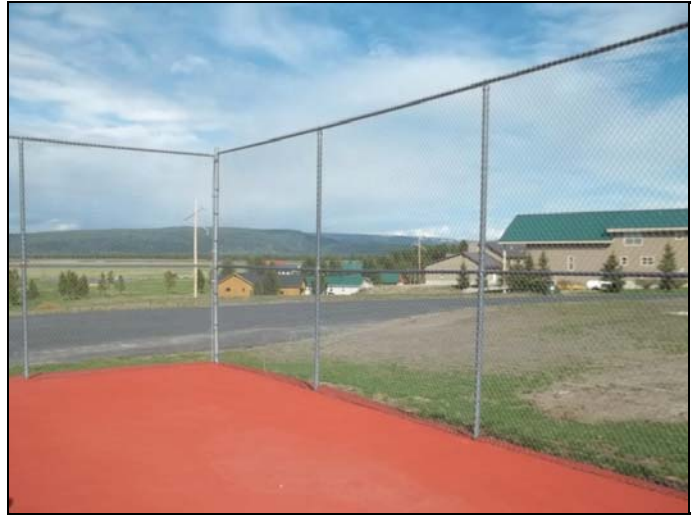
Comp #: 1003 Chain Link Fencing - Replace

The chain link fencing is in good condition. Due to the extended useful life associated with this component, reserve funding is not appropriate. Make local repairs as necessary as an operating expense. No reserve funding necessary.
