# Island Park Village

## Level 1 Reserve Study

**Report Period – 10/01/2013 – 9/30/2014**

<b>Date of Property Inspection</b>	<b>5/21/2013</b>
<b>Prepared By</b>	<b>Dale Gifford</b>
<b>Analysis Method</b>	<b>Cash Flow</b>
<b>Funding Goal</b>	<b>Full Funding</b>

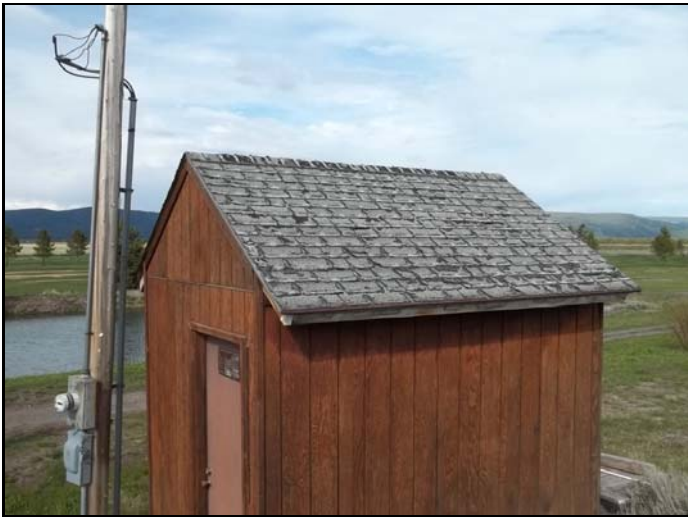
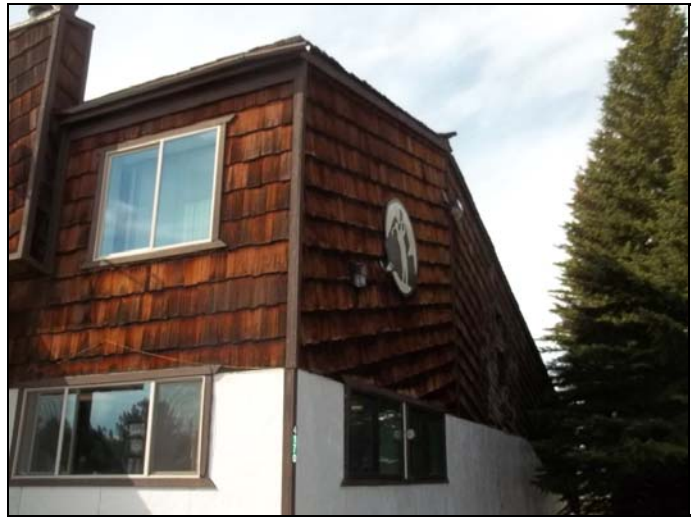
Comp #: 107 Pitched Roof - Shake - Replace

*Location:* Clubhouse Roof

\$6.00/Sq.ft.; Estimate to replace wood shingle roof

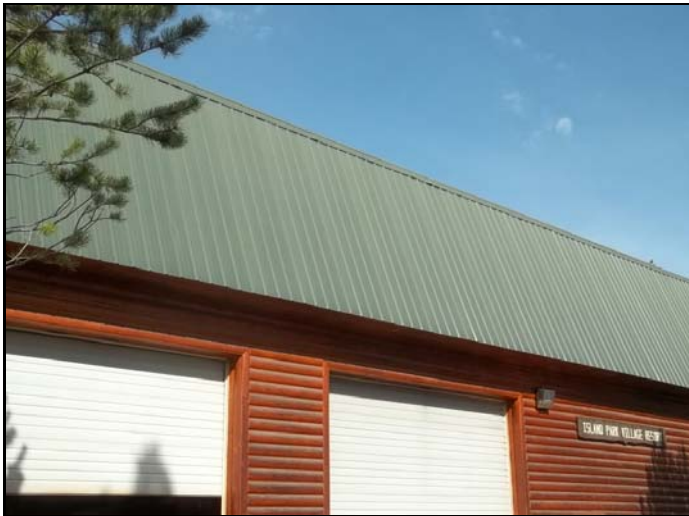
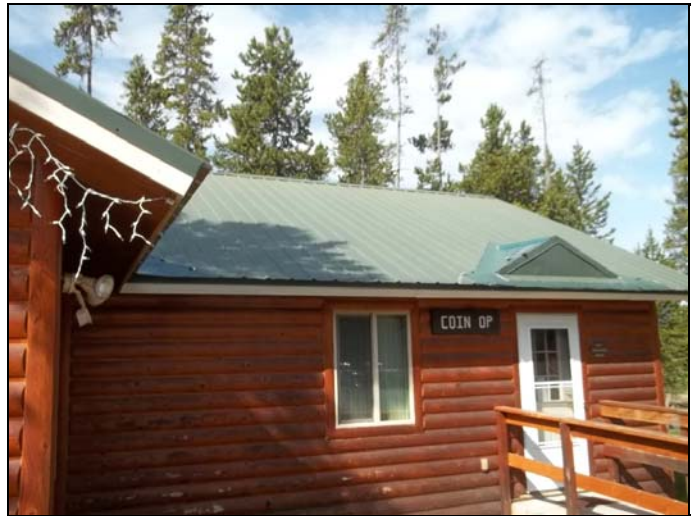
Comp #: 108 Pitched Roof - Metal - Replace

*Location:* **Master Building Roofs**

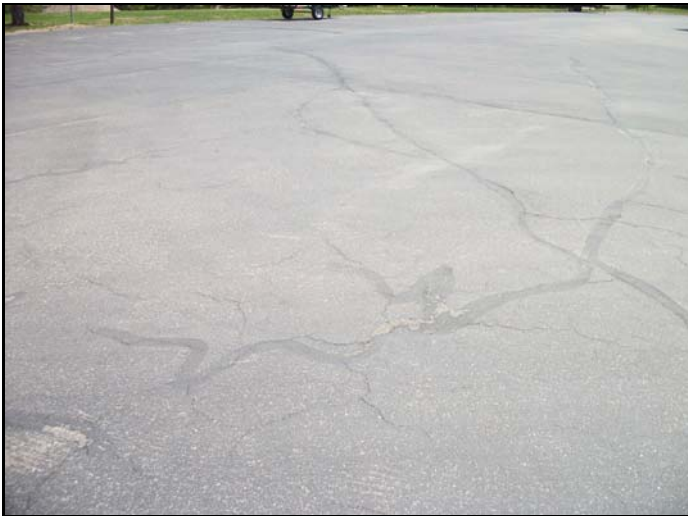
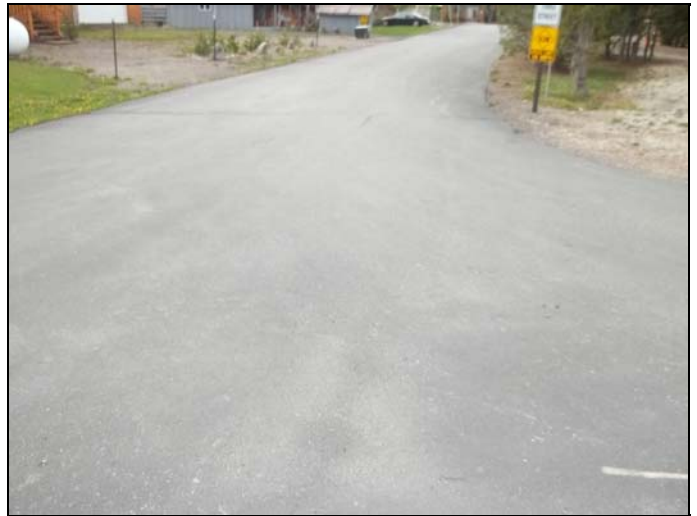
Comp #: 401 Asphalt - 2012 - Maintenance

*Location:* **Community Roads**

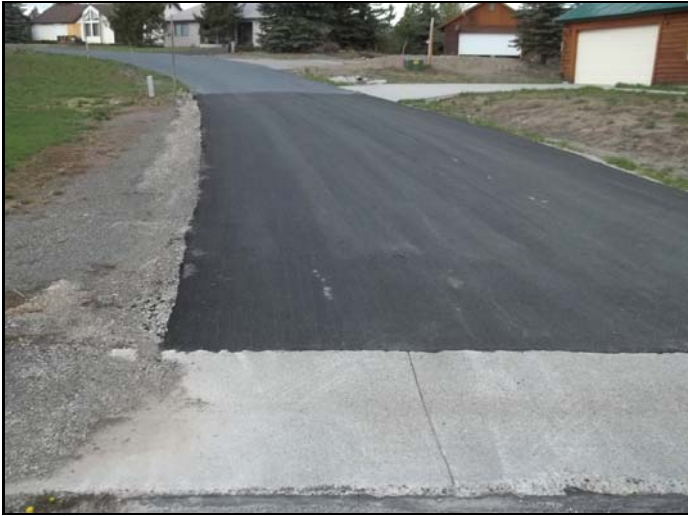
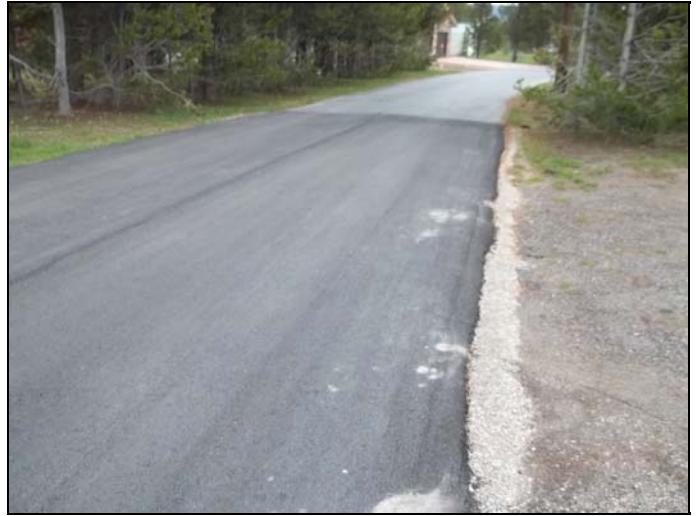
Comp #: 402 Asphalt - Seal Coat

*Location:* **Community Roads**

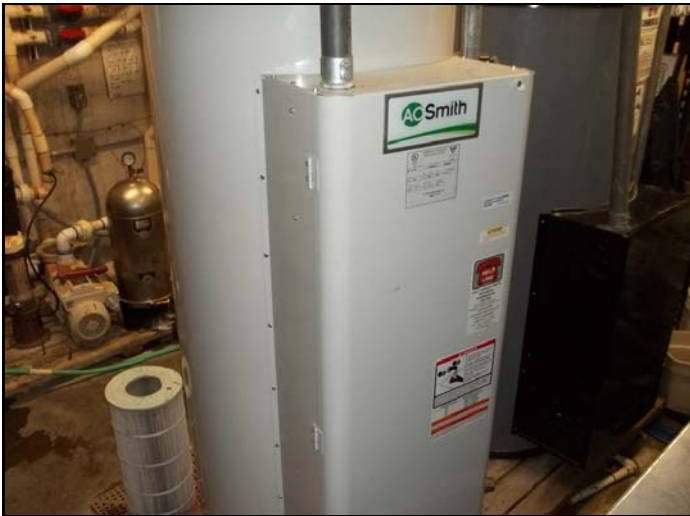
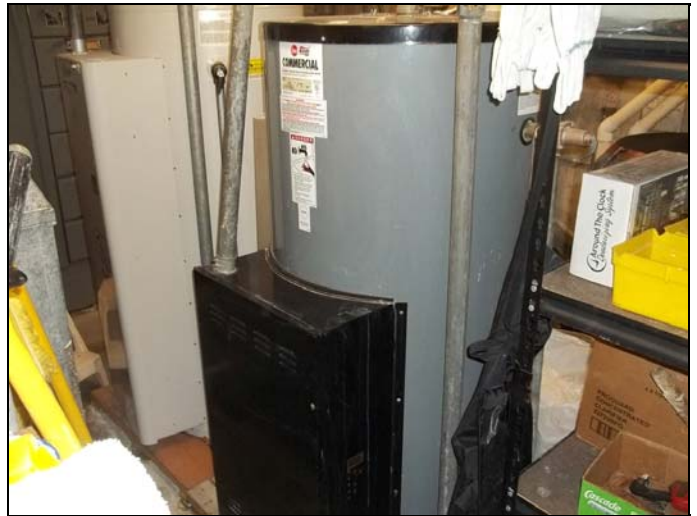
Comp #: 703 Clubhouse Commercial Water Heaters - Replace

*Location:* Clubhouse Pool Equipment Room

<p><b>Quantity description:</b></p> <p>(1) - A.O. Smith DRE 80 100 (1) - Rheem ES85-45-G (2) - Total</p>
--

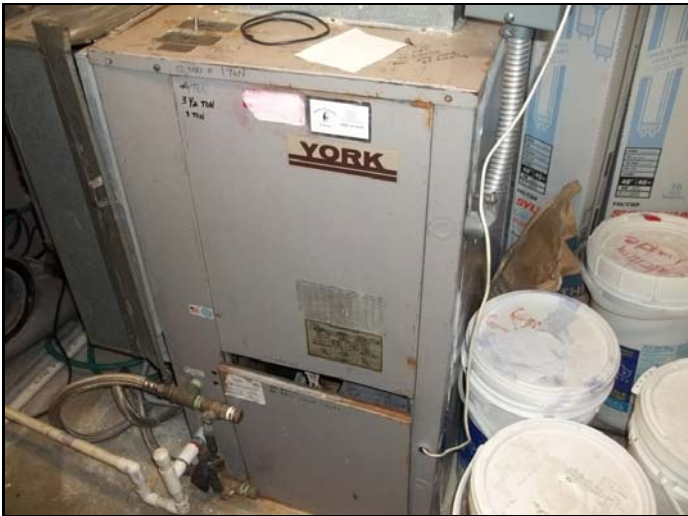
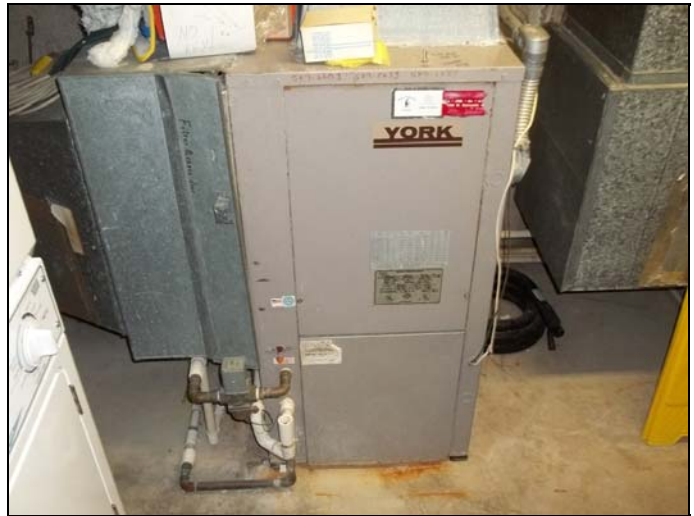
Comp #: 705 Clubhouse Heat Pumps - Replace

*Location:* Clubhouse Pool Equipment Room

*Quantity:* (5) Heat Pumps

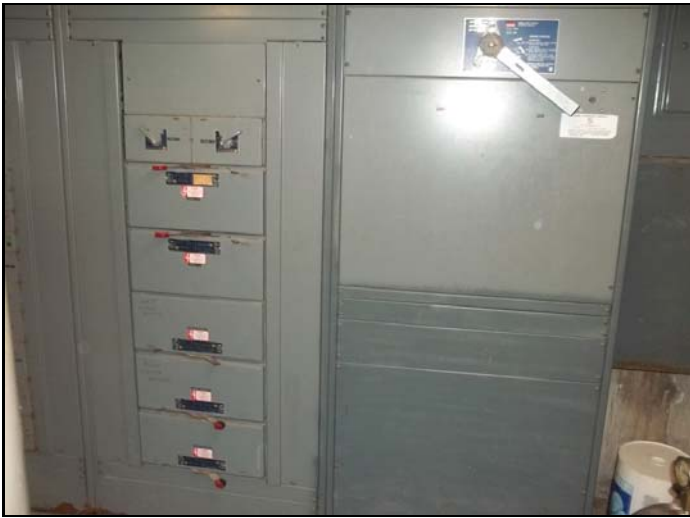
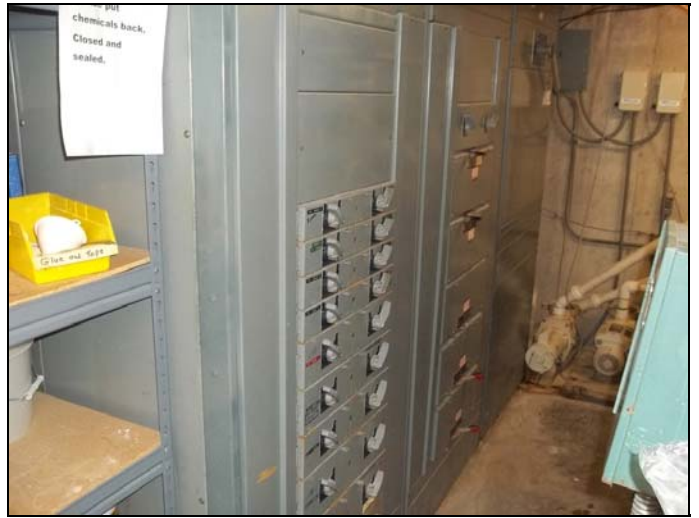
Comp #: 990 Clubhouse Electrical Panel - Replace

Although this component has an extended useful life, research with the client reveals this component is in need of replacement do to code requirements and safety hazard.

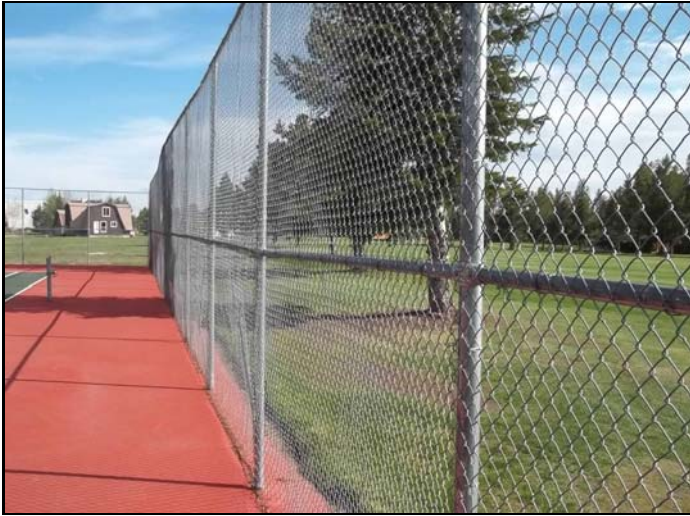
Comp #: 1003 Chain Link Fencing - Replace

The chain link fencing is in good condition. Due to the extended useful life associated with this component, reserve funding is not appropriate. Make local repairs as necessary as an operating expense. No reserve funding necessary.

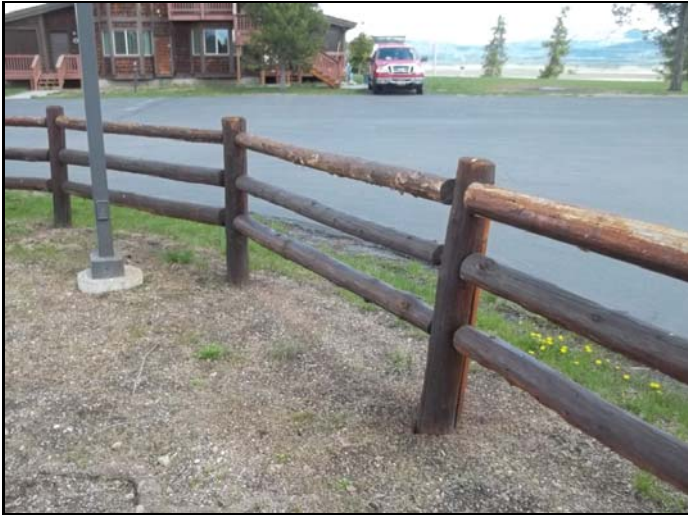
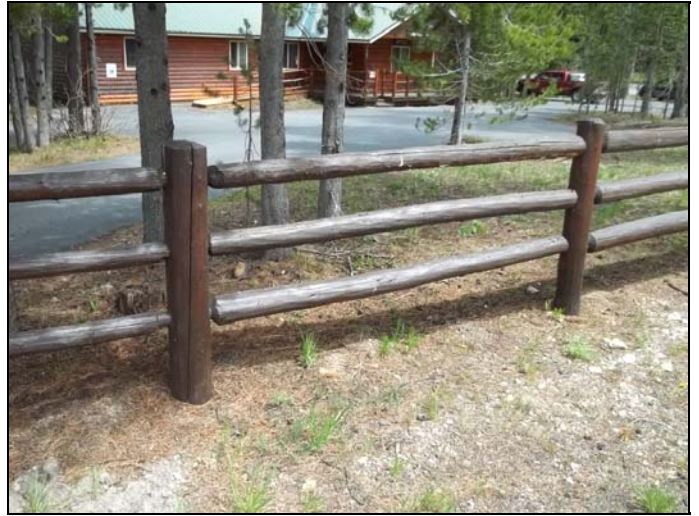
Comp #: 1009 Split Rail Fencing - Replace

The split rail fencing is in fair to poor condition. Broken and missing rails were noted at the time of inspection. Expect a useful life of approximately 15 years from this component. Remaining life based on current condition.

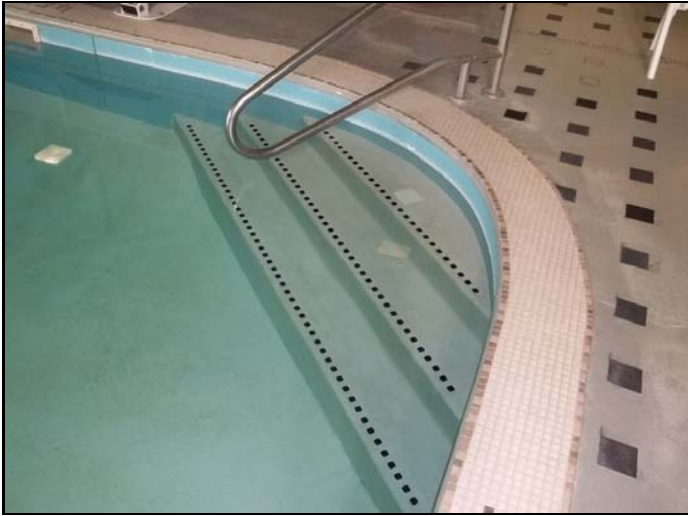
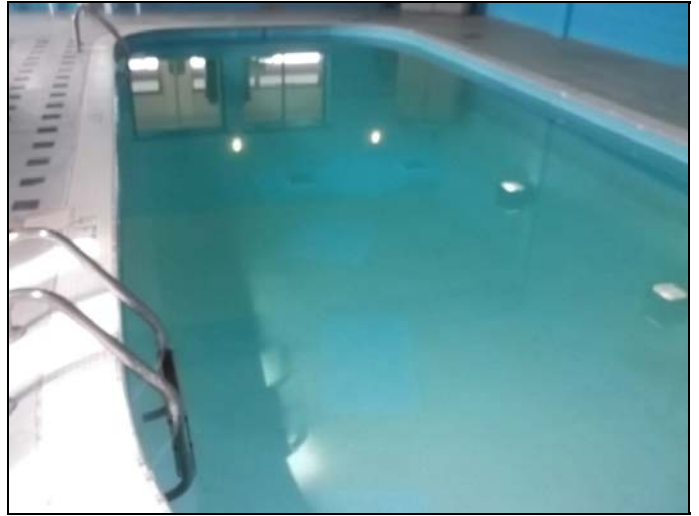
Comp #: 1101 Pool - Resurface

The pool surface is in fair to poor condition. Discoloration, cracks, edge pulling away from coping stones and rough areas were noted at the time of the inspection. Perform regular, professional maintenance and keep debris from collecting at the bottom to ensure full life from this component. We recommend funding to resurface the pool every 10 to 12 years depending on use and wear. Remaining life based on current age.

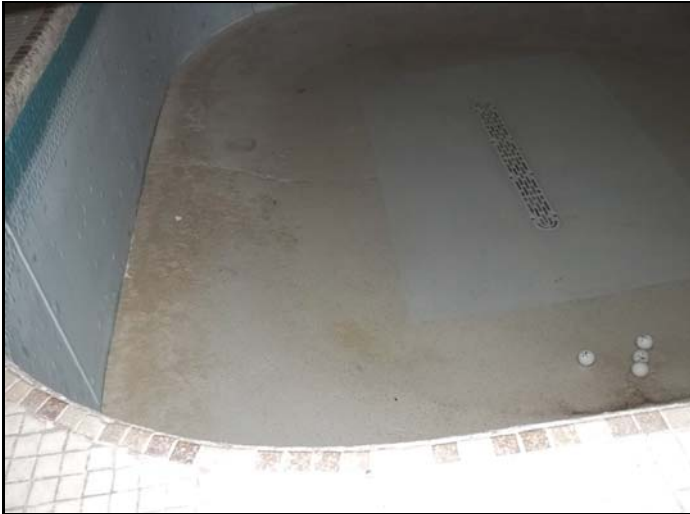
Comp #: 1103 Wading Pool - Resurface

The wading pool surface is in poor condition. The client reports this component has leak issues. Discoloration was noted at the time of the inspection. Expect to replaster this component approximately every 8 - 10 years. Remaining life based on current condition.

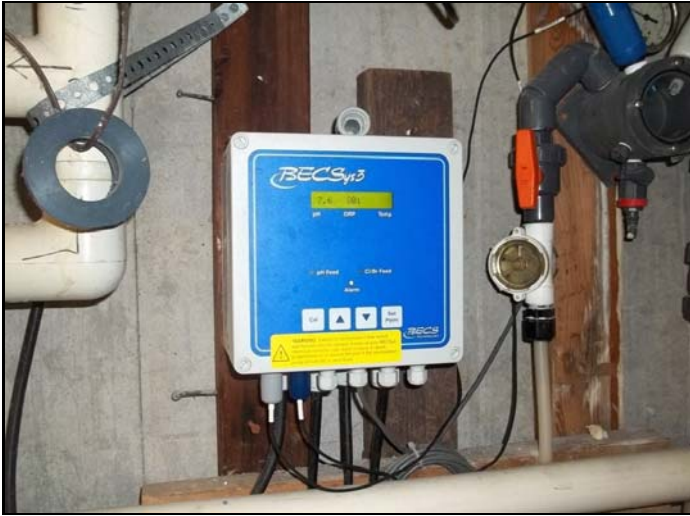
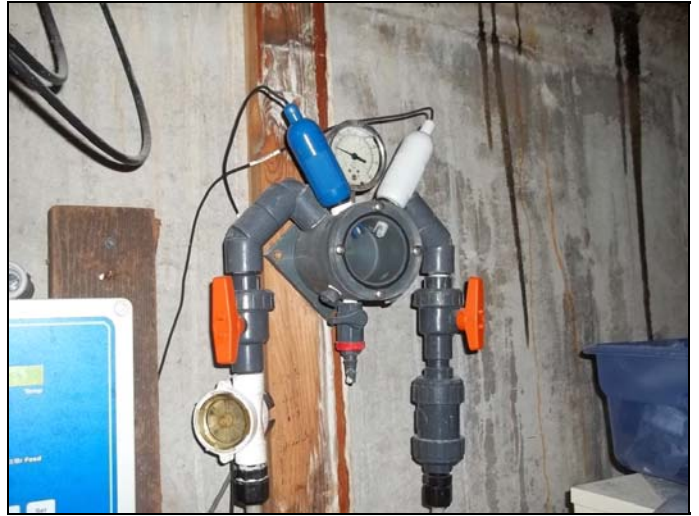
Comp #: 1111 Chemical Controller System - Replace

The pool chemical controller system is in good condition. No problems were noted or reported at time of the inspection. We recommend funding to replace this system approximately every 10 years to ensure proper function and to keep up with current technology. Remaining life based on current age.

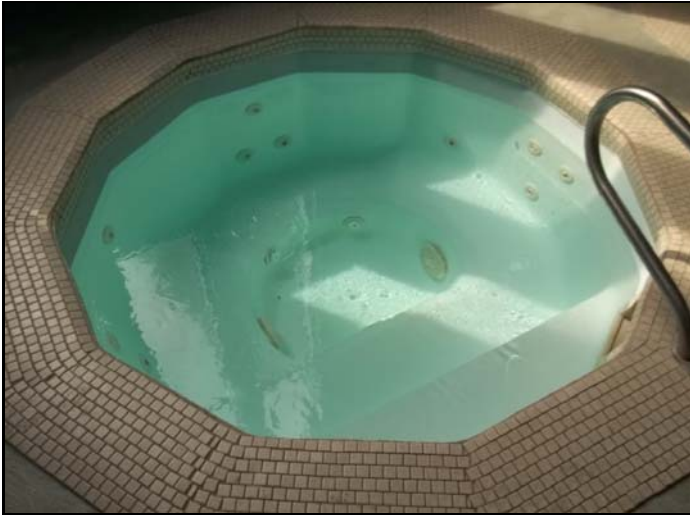
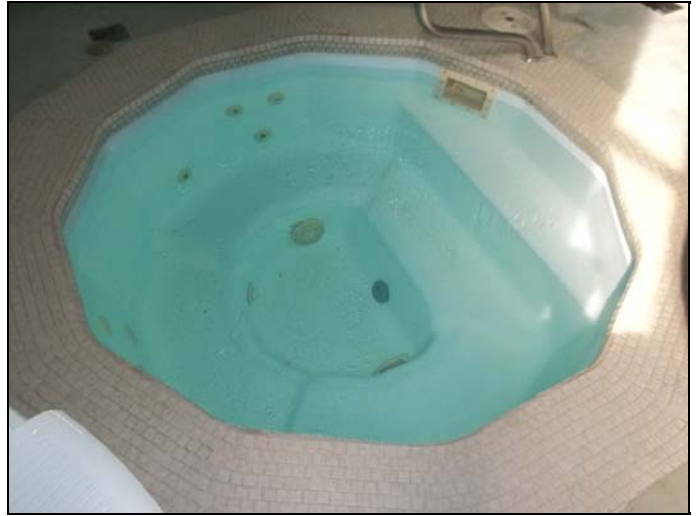
Comp #: 1115 Spa - Replace

The spas are older and still in functional condition. We recommend funding to replace this component in the next few years. We recommend funding to replace this type of spa every 20 Years. Remaining life based on current age.

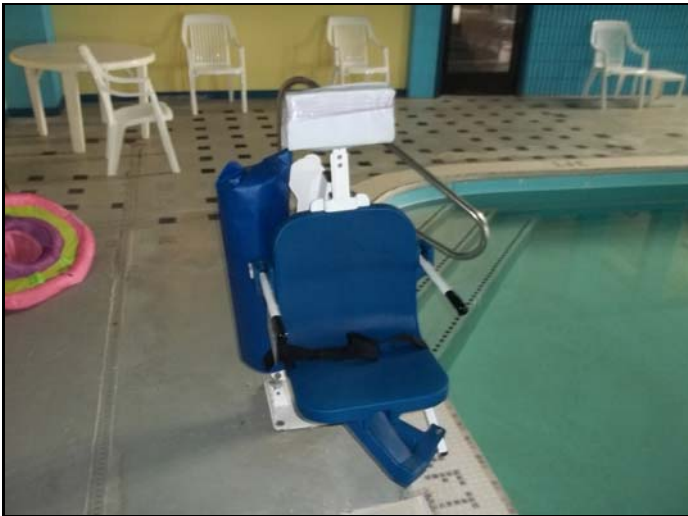
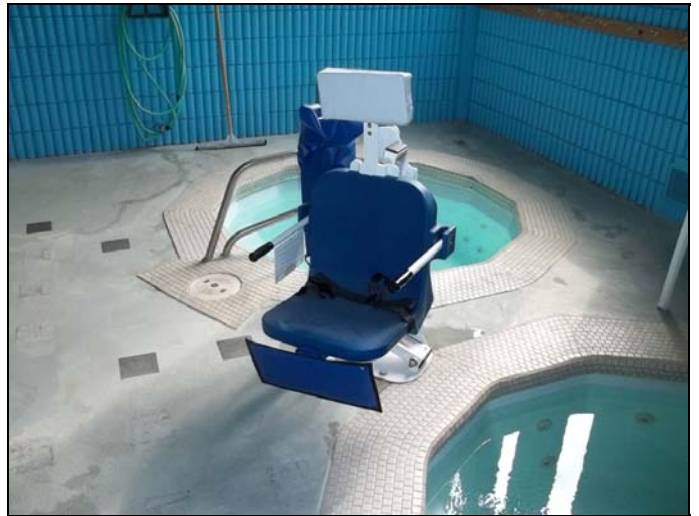
Comp #: 1190 Pool & Spa Lifts - Replace

The pool and spa lifts are in good condition. No problems were reported at the time of the inspection. We recommend funding to replace this component approximately every 15 years. Remaining life based on current age.

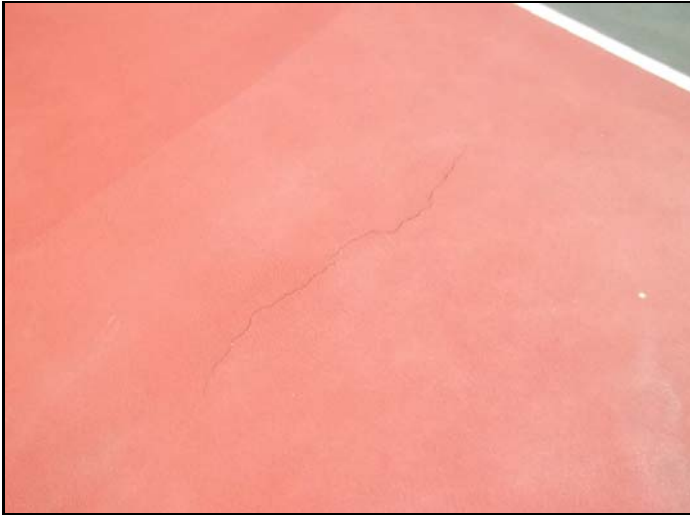
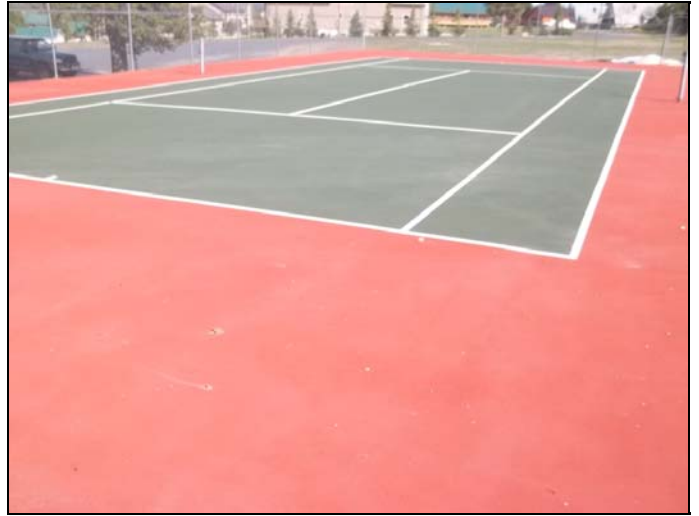
Comp #: 1201 Tennis Court - Repair/Resurface

The tennis court is in good condition. No significant cracking or surface loss were noted at the time of the inspection. Expect to repair/resurface this component approximately every 10 - 15 years assuming normal use and wear. Remaining life based on current age.

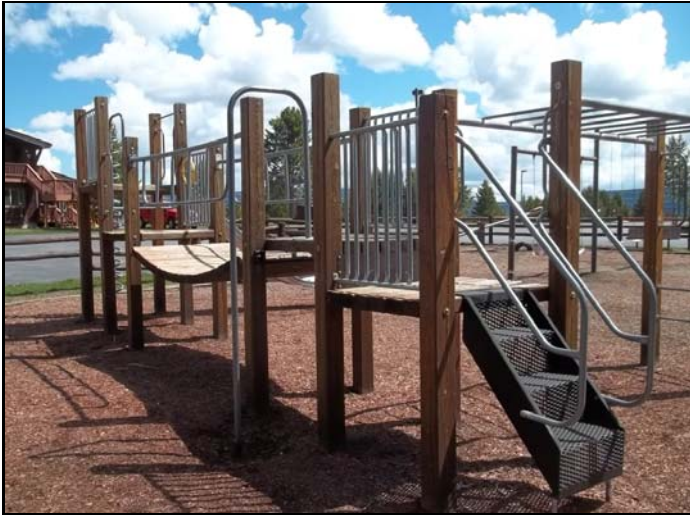
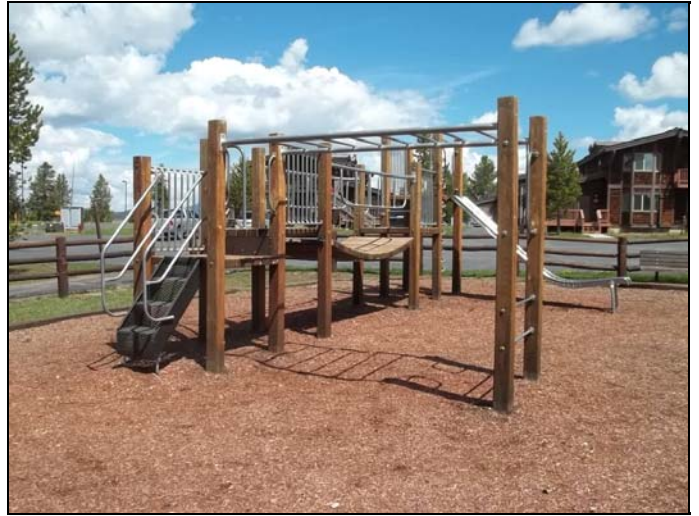
Comp #: 1301 Play Structure - Replace

The play structure is in fair condition. Seal wood as necessary as an operating expense. Expect a useful life of approximately 15 - 20 years from this component. Remaining life based on current age and condition.

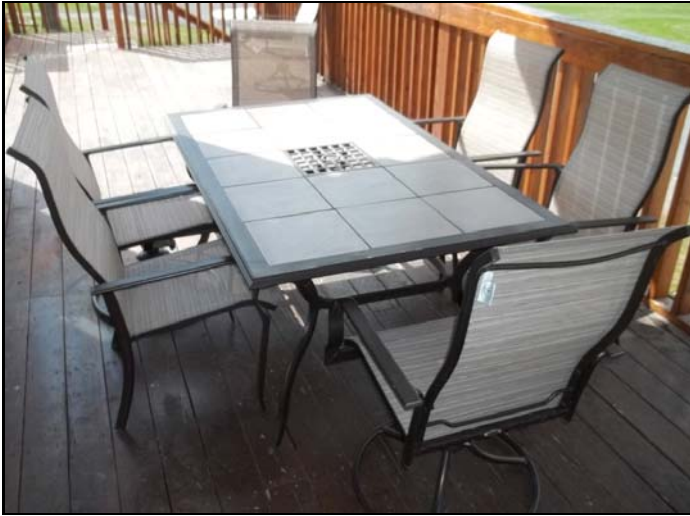
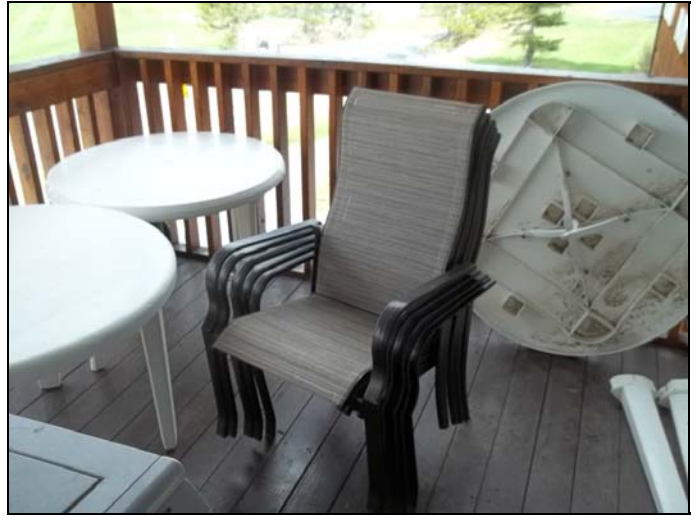
Comp #: 1309 Patio Furniture - Replace

The patio furniture is in fair condition. Expect a useful life of approximately 6 - 8 years from this component. Remaining life based on current condition.

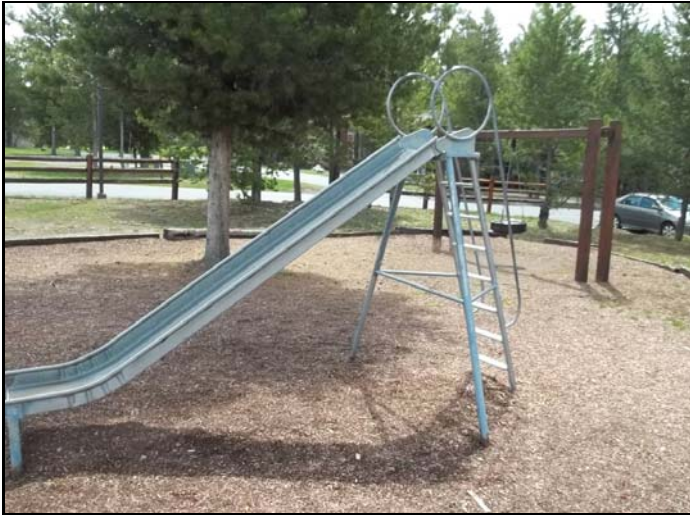
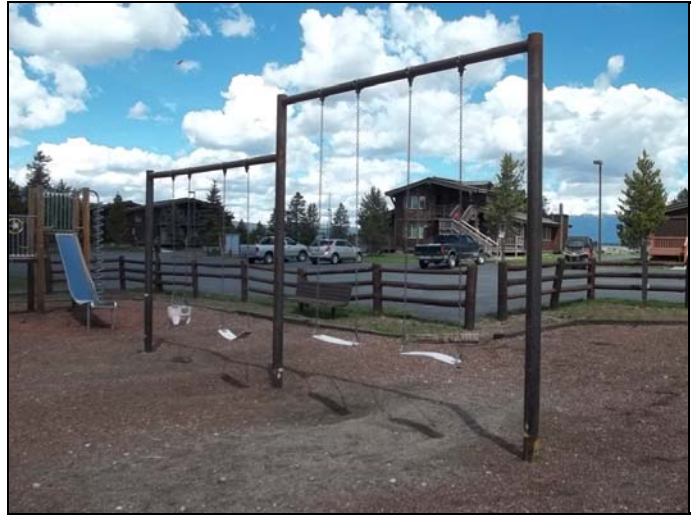
Comp #: 1390 Playground Equipment - Partial Replace

The playground equipment is in generally fair condition. We recommend funding to partially replace this component approximately every 10 years. Remaining life based on current age and condition.

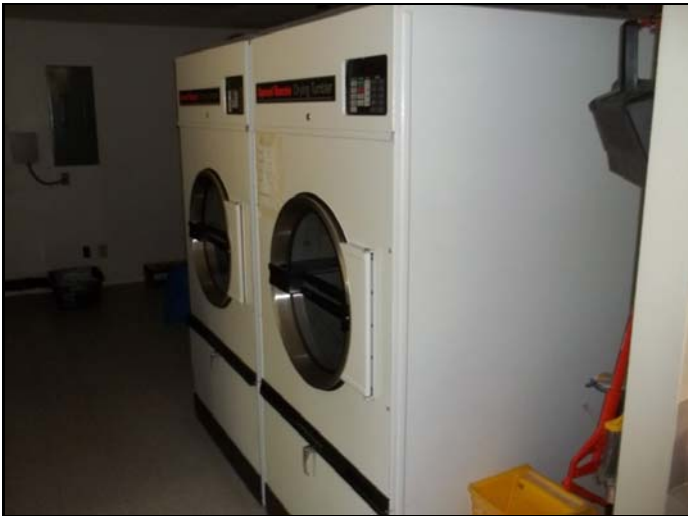
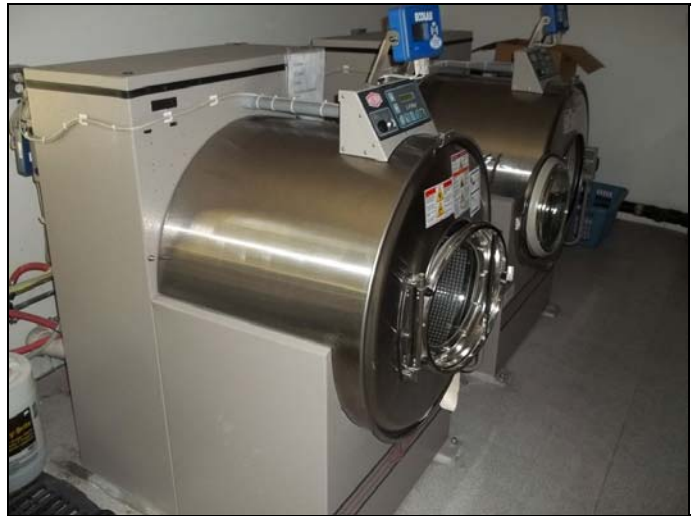
Comp #: 1401 Commercial Laundry Equipment - Replace

The commercial laundry equipment is in working condition. We recommend funding to replace this component in the next few years. We recommend replacing this component approximately every 15 - 20 years. Remaining life based on current age.

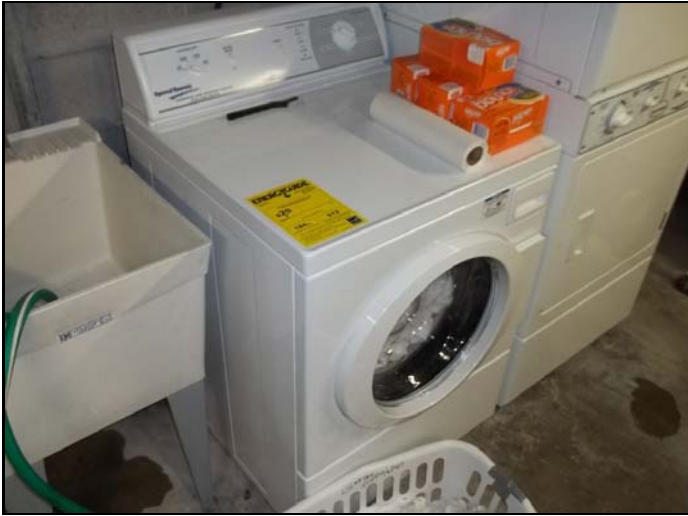
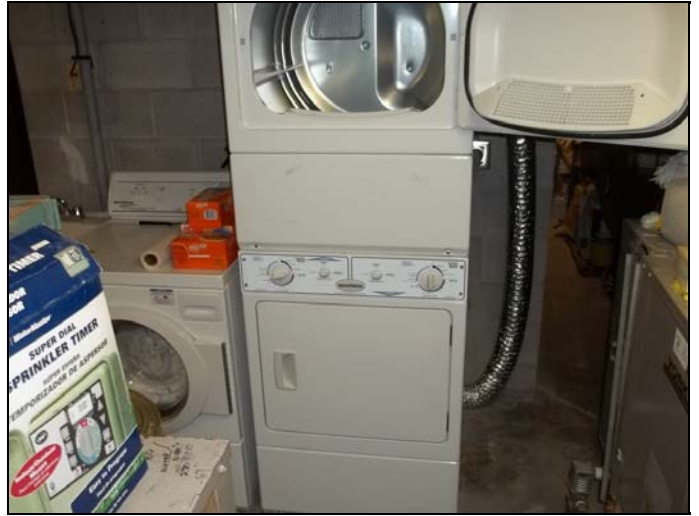
Comp #: 1401 Laundry Equipment - Clubhouse - Replace

The laundry equipment is in good condition. No problems were noted or reported at the time of the inspection. We recommend replacing this component approximately every 12 years. Remaining life based on current age.

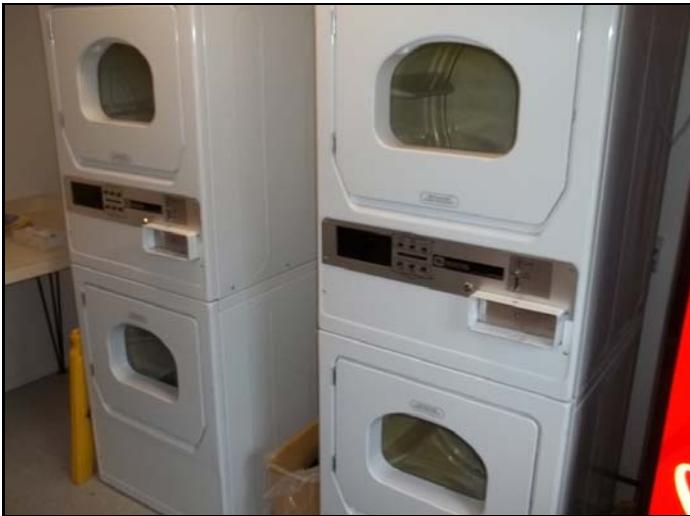
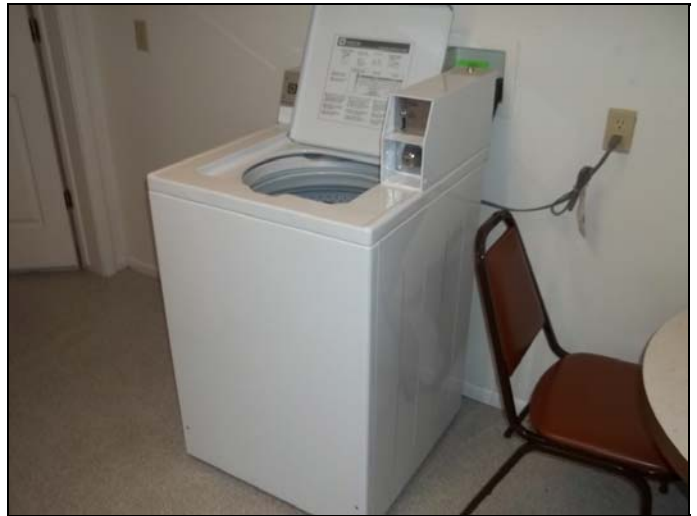
Comp #: 1401 Laundry Equipment - Coin-Op - Replace

The laundry equipment is in good condition. No problems were noted or reported at the time of the inspection. We recommend replacing this component approximately every 12 years. Remaining life based on current age.

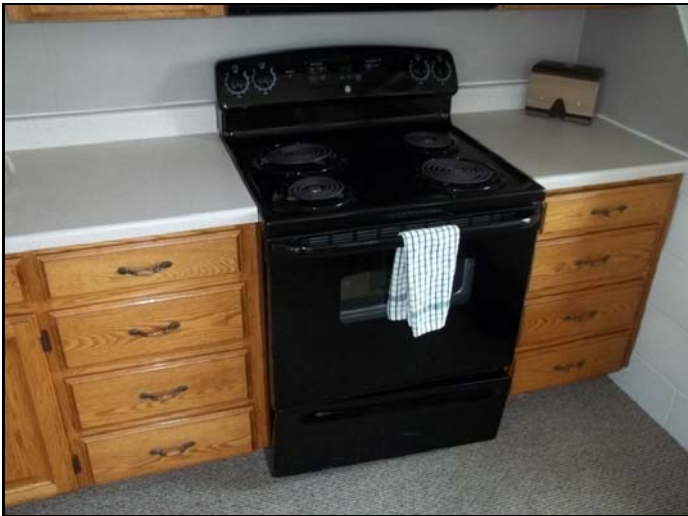
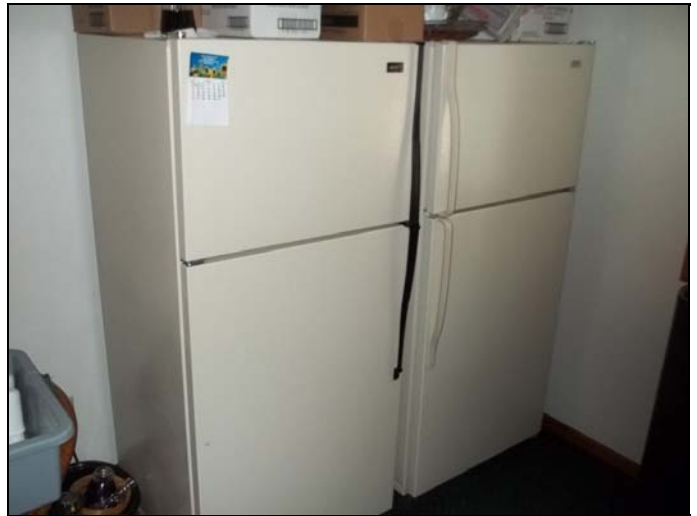
Comp #: 1402 Appliances - Replace

The appliances are in working condition. We recommend funding to replace this component approximately every 12 - 15 years. Remaining life based on current age and condition.

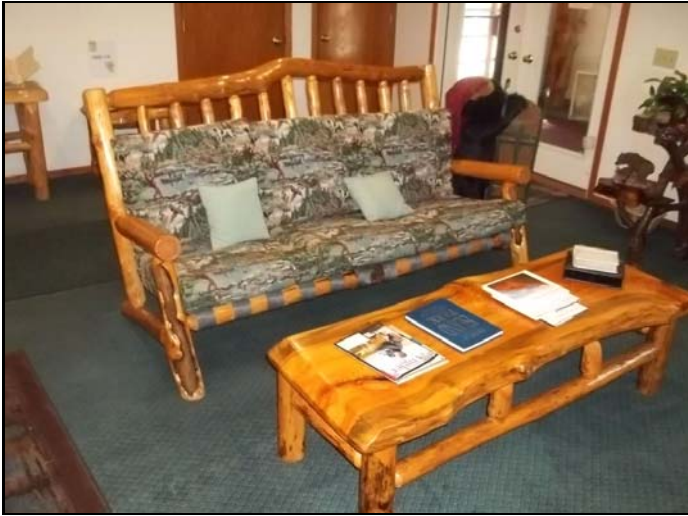
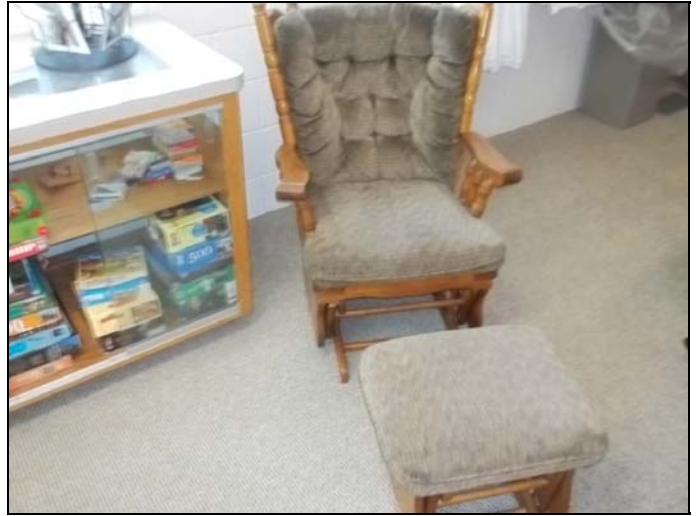
Comp #: 1405 Furniture - Replace

The furniture is in fair to poor condition. We recommend funding to make significant replacements to furniture approximately every 10 years to maintain appearance and keep up with decorative tastes. Remaining life based on current age and condition.

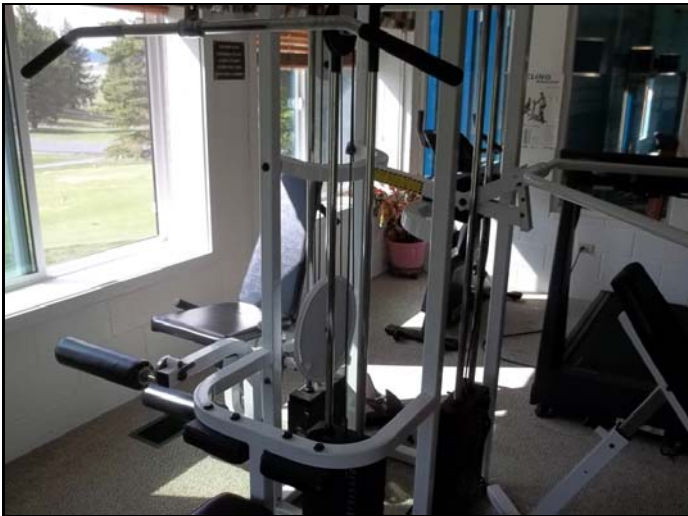
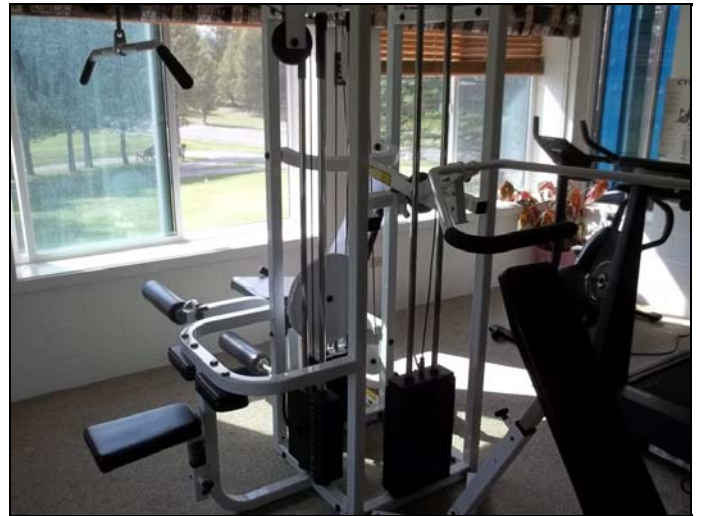
Comp #: 1406 Fitness Equipment - Replace

The fitness equipment has passed its useful life. We recommend funding to replace this component in the next few years. We recommend repairing broken cables and ripped upholstery as necessary as an operating expense and funding to completely replace the fitness equipment approximately every 15 years. Remaining life based on current age and condition.

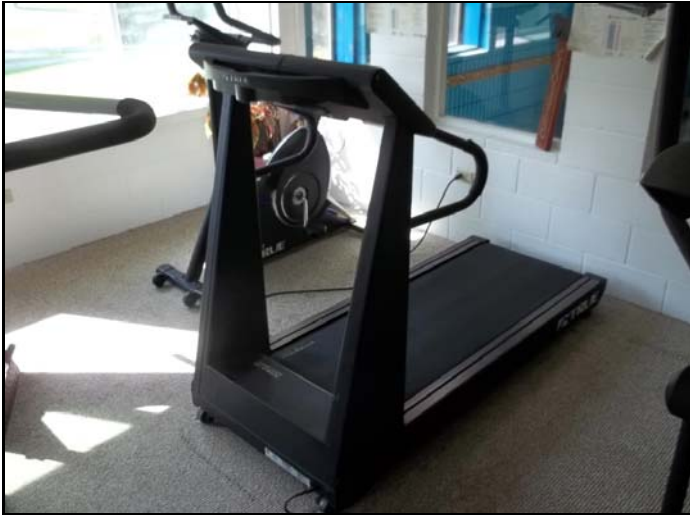
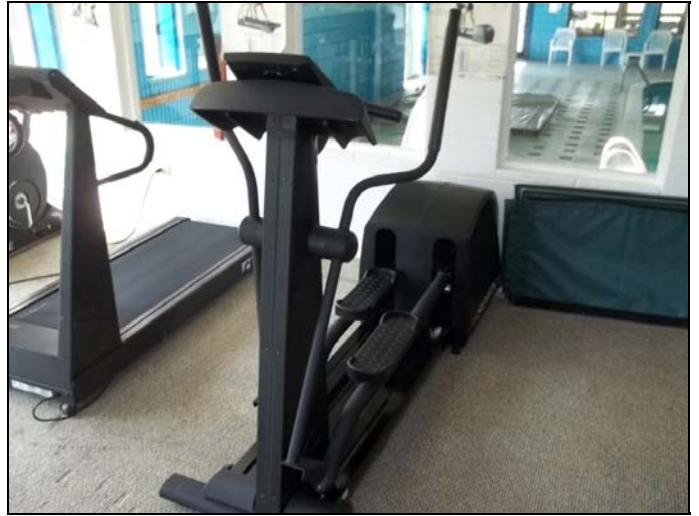
Comp #: 1407 Cardio Equipment - Replace

The cardio fitness equipment has passed its useful life. We recommend funding to replace this component in the next few years. Due to higher use and wear expect to replace this equipment approximately every 8 years. Remaining life based on current age.

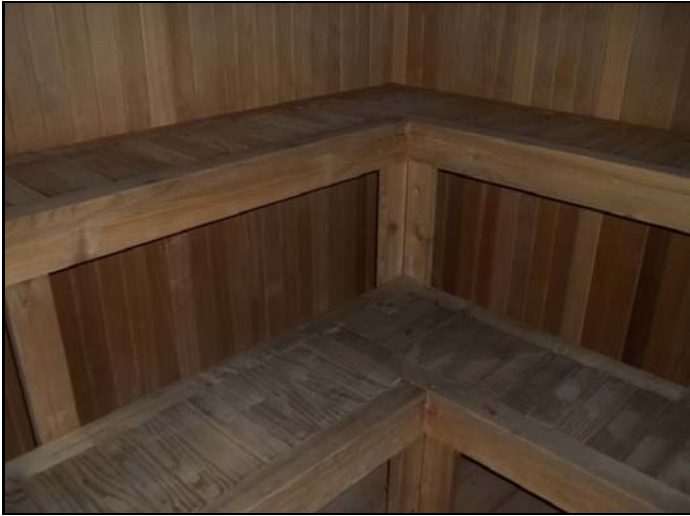
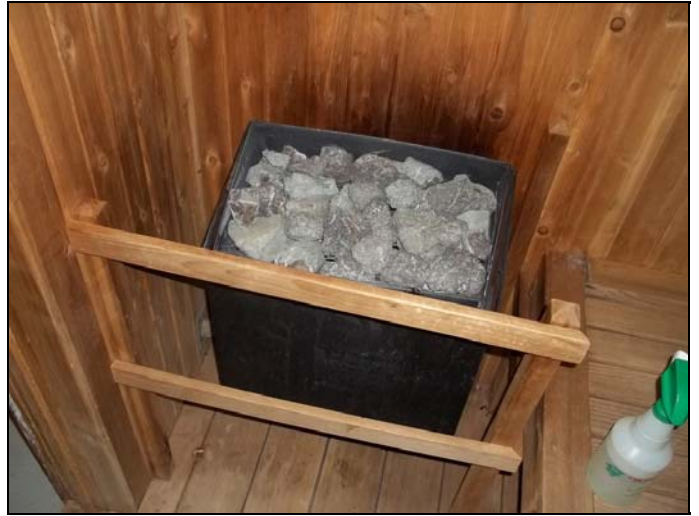
Comp #: 1409 Sauna Room - Remodel

The sauna interior has passed its useful life. We recommend funding to remodel it in the next few years. We recommend remodel this component approximately every 20 years to maintain appearance. Remaining useful life based on current age and condition.

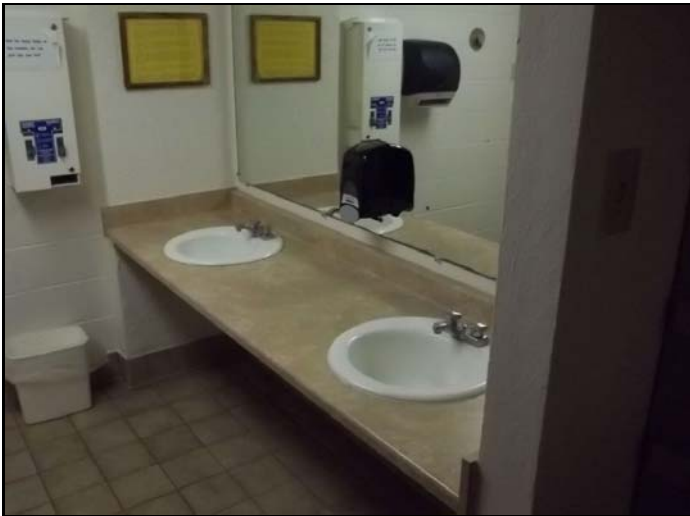
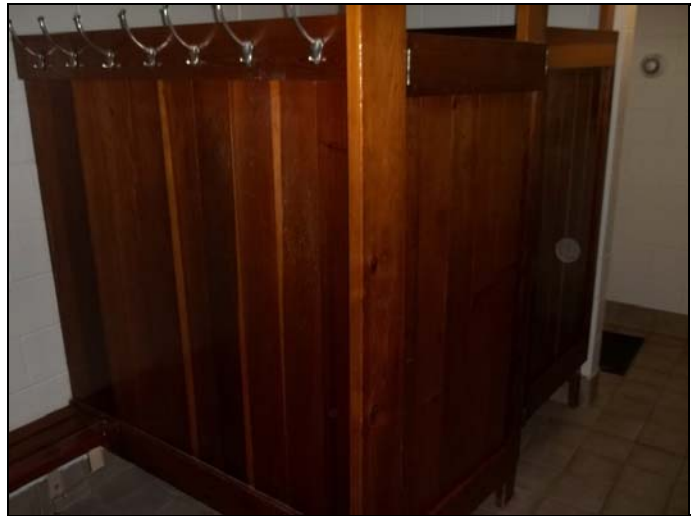
Comp #: 1413 Locker Rooms - Remodel

The restrooms are in good to fair condition. We recommend funding to remodel these restrooms approximately every 18 years to maintain appearance and keep up with current decorative tastes. Remaining life based on current age and condition.

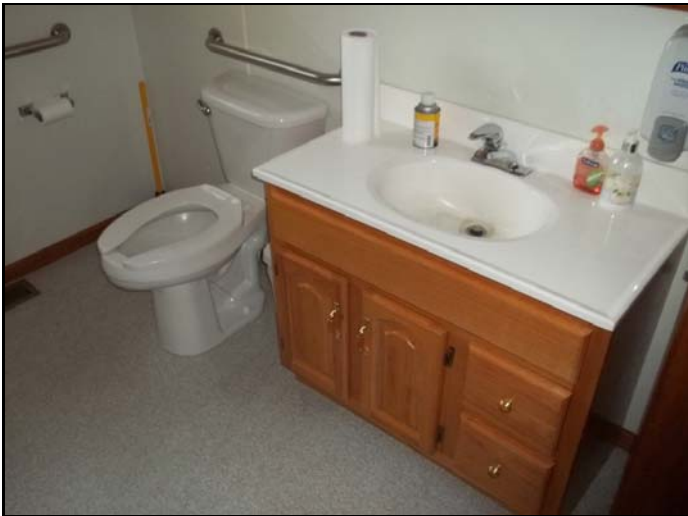
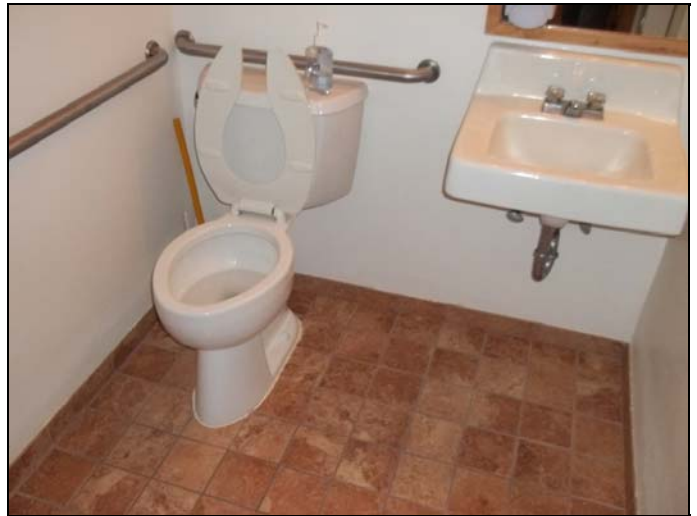
Comp #: 1413 Restroom - Remodel

The restrooms are generally in good condition. No appearance concerns were noted at the time of the inspection. We recommend funding to remodel these restrooms approximately every 18 years to maintain appearance and keep up with current decorative tastes. Remaining life based on current age and condition.

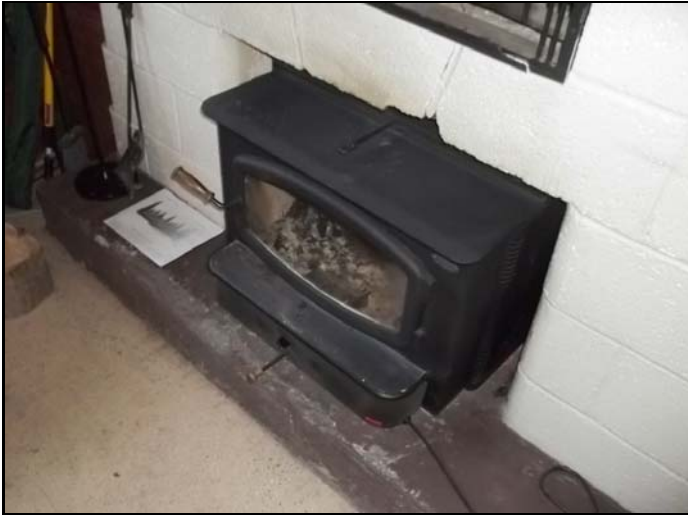
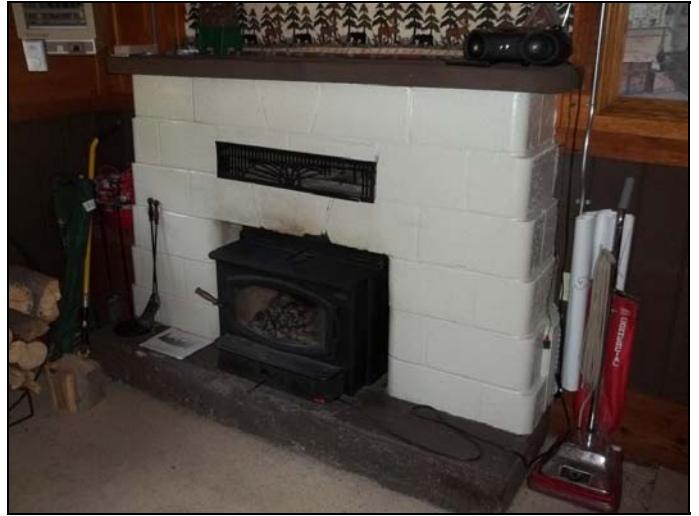
Comp #: 1490 Fireplace - Replace

The fireplace is in good condition. No problems were noted at the time of the inspection. We recommend funding to replace this component approximately every 8 - 10 years. Remaining life based on current age.

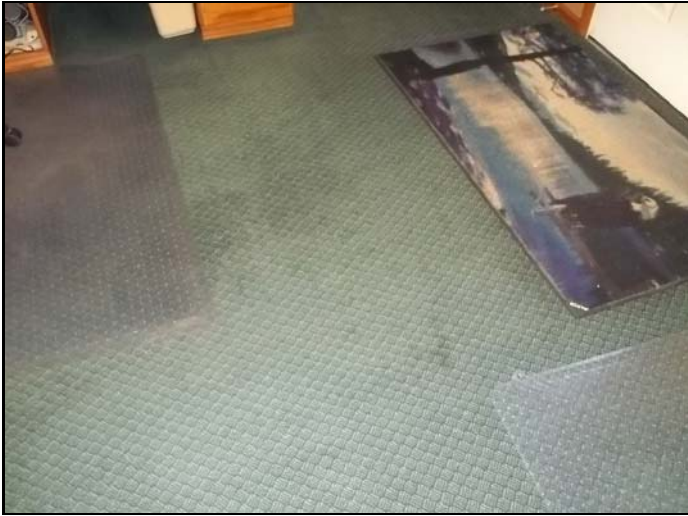
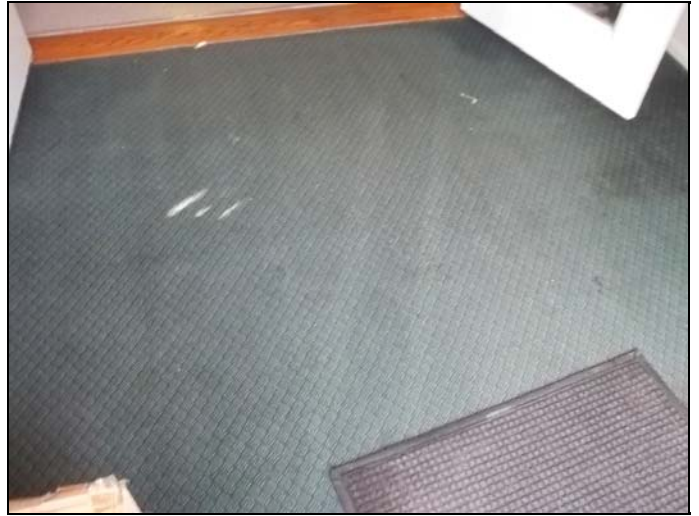
Comp #: 1501 Carpeting - Replace

The carpeting is generally in poor condition and has passed its useful life. We recommend funding to replace this component in the next few years. Expect to replace this component approximately every 8 - 10 years assuming normal use and wear. Remaining life based on current age and condition.
