# Island Park Village

## Level 1 Reserve Study

**Report Period – 10/01/2013 – 9/30/2014**

<b>Date of Property Inspection</b>	<b>5/21/2013</b>
<b>Prepared By</b>	<b>Dale Gifford</b>
<b>Analysis Method</b>	<b>Cash Flow</b>
<b>Funding Goal</b>	<b>Full Funding</b>

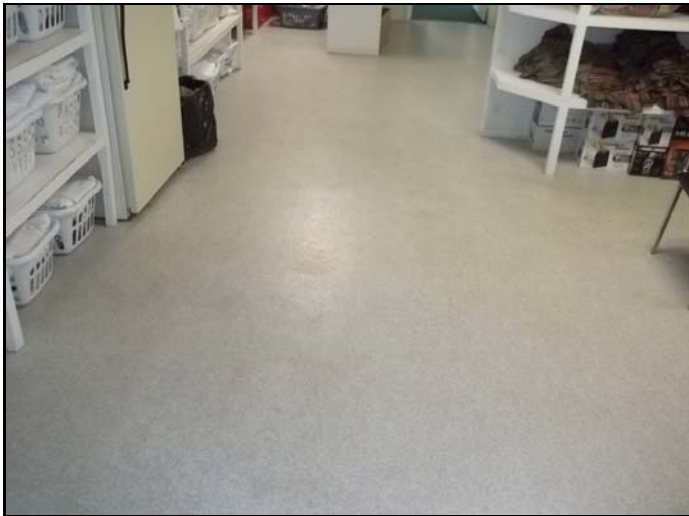
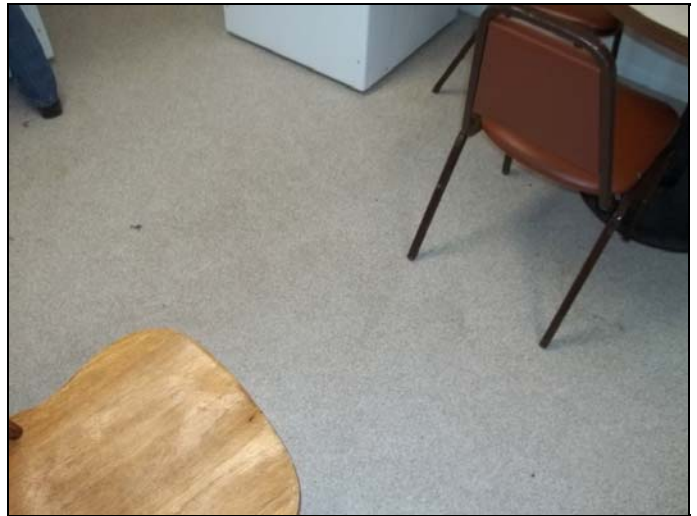
Comp #: 1502 Vinyl - Replace

The vinyl flooring is in good condition. No problems were noted at the time of the inspection. Expect a useful life of approximately 15 - 20 years from this component. Remaining life based on current age and condition.

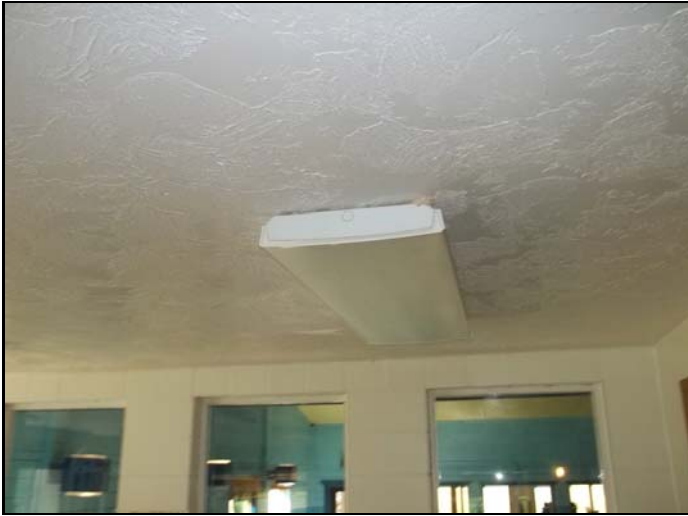
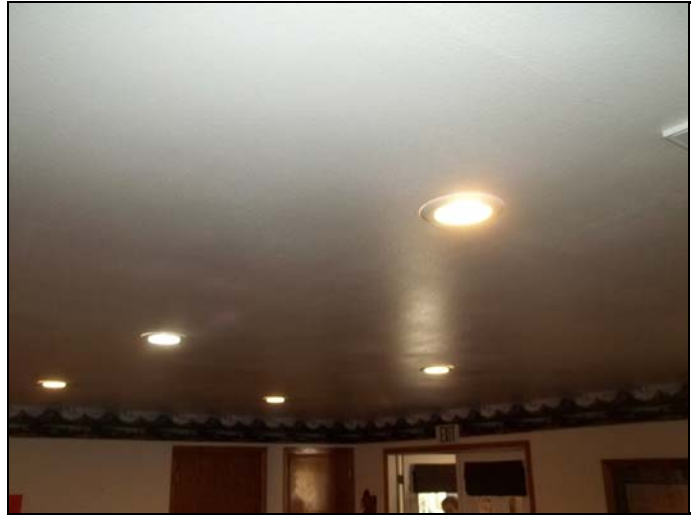
Comp #: 1601 Interior Light Fixtures - Replace

The light fixtures are generally in fair condition. The fluorescent fixtures are going to need to be changed from T12 to T8 fixtures in the near future. Expect to replace these lights approximately every 18 years. Remaining life based on current age and condition.

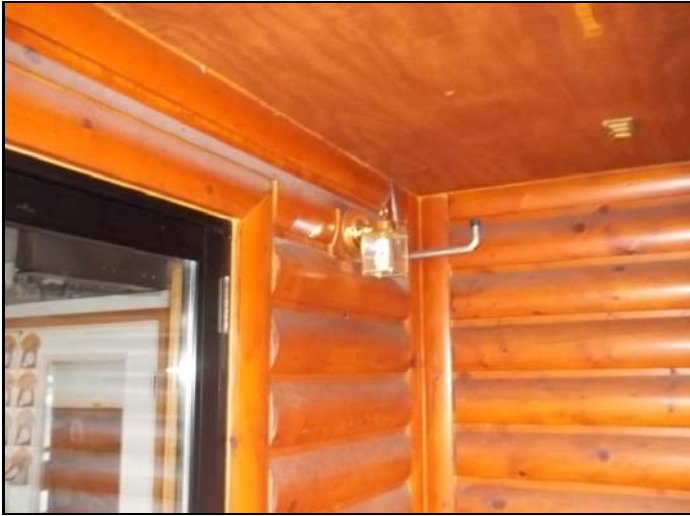
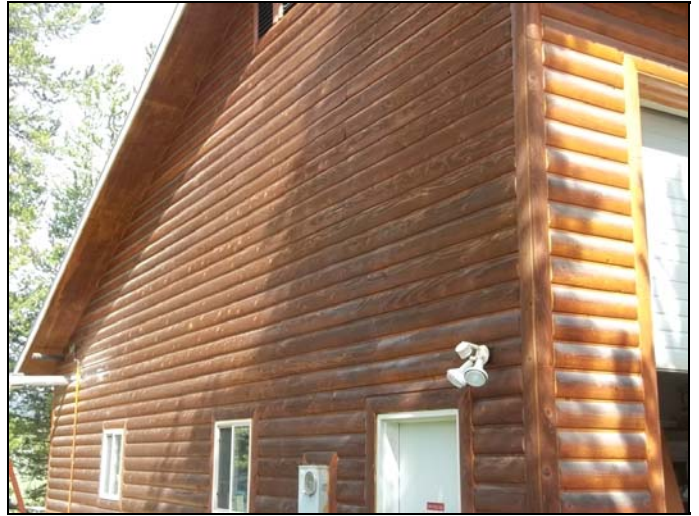
Comp #: 1602 Exterior Light Fixtures - Replace

The exterior light fixtures are in fair condition. Expect to replace these lights approximately every 16 years to maintain appearance. Remaining life based on current age and condition.

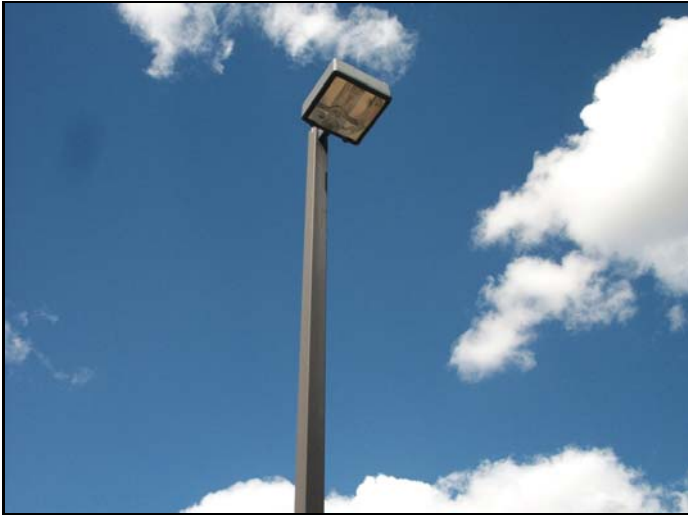
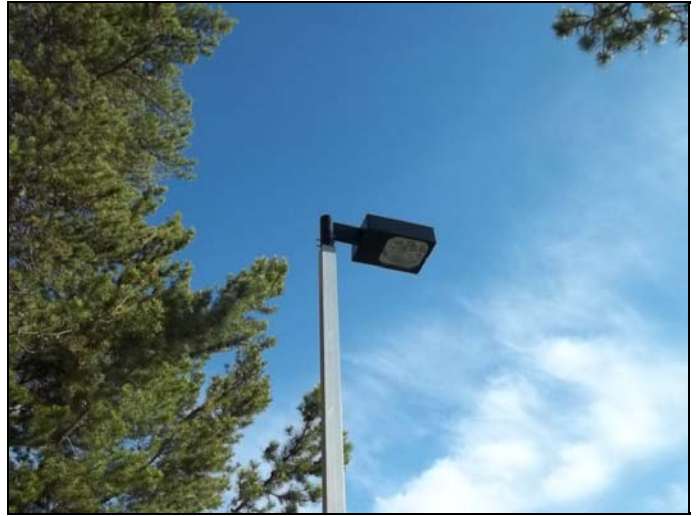
Comp #: 1609 Street Light Fixtures - Replace

The street light fixtures are in working condition. No expectation to replace the light poles. Paint poles as necessary as an operating expense. Although poles may reach an extended life we recommend funding to replace the street light fixtures approximately every 20 years to ensure proper function. Remaining life based on current age.

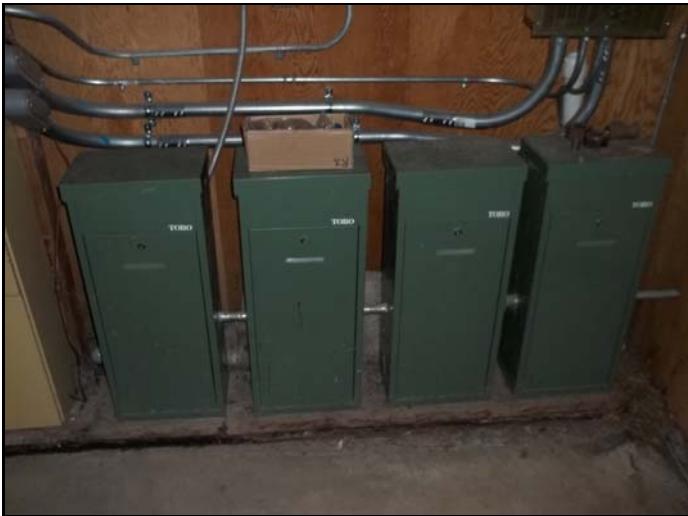
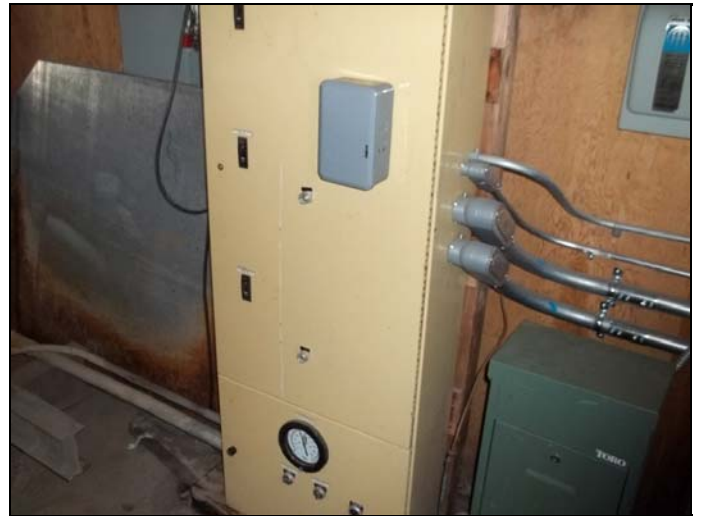
Comp #: 1702 Frequency Broadcaster & Computer - Replace

The frequency broadcaster and computer system was replaced in fiscal year 2013. Expect to replace this component approximately every 10 years. Remaining life based on current age.

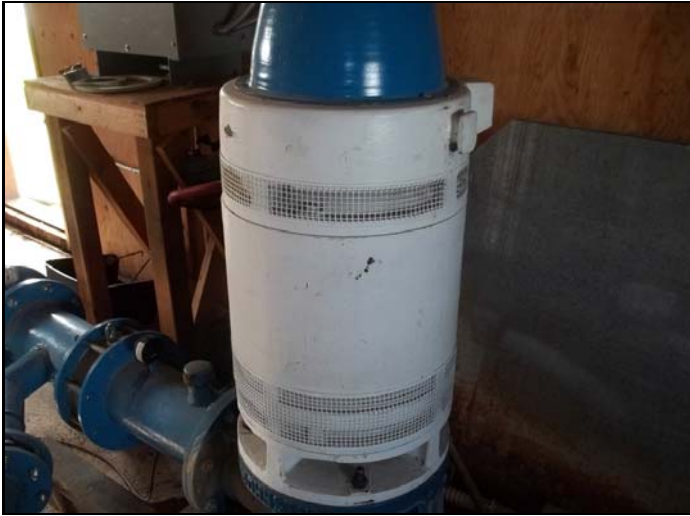
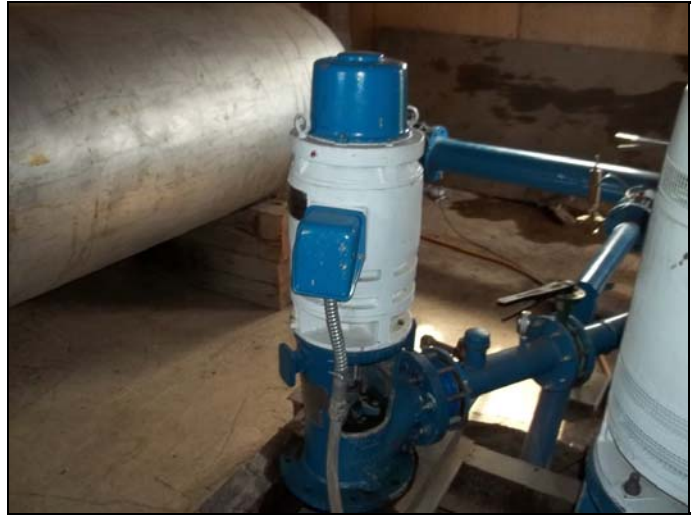
Comp #: 1705 Golf Course Irrigation Pumps - Rebuild/Replace

The pumps are in working condition. Expect an average life of 10 to 15 years from this pump. Remaining life based on current age.

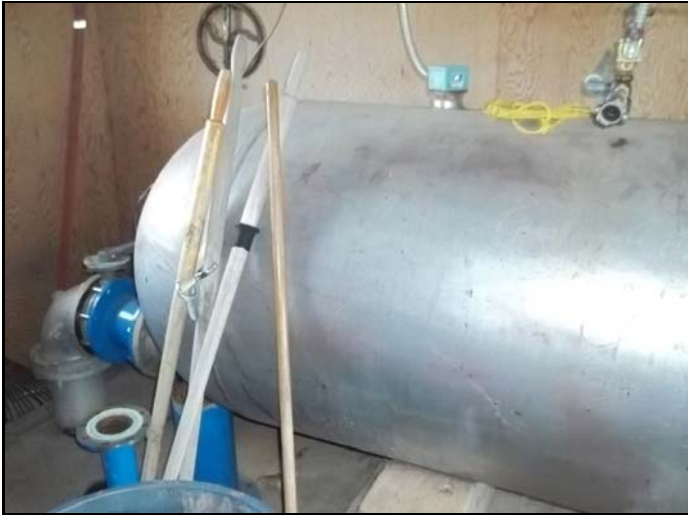
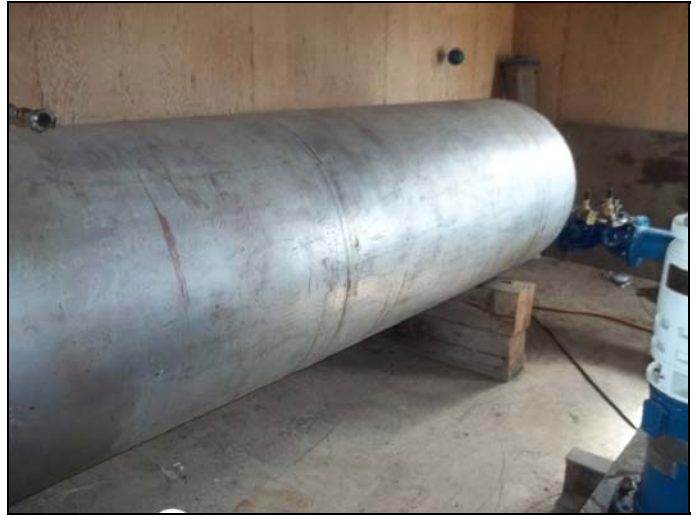
Comp #: 1790 Expansion Tank - Replace

The expansion tank is in working condition. No problems were reported at the time of the inspection. We recommend funding to replace it every 15 - 20 years. Remaining life based on current age.

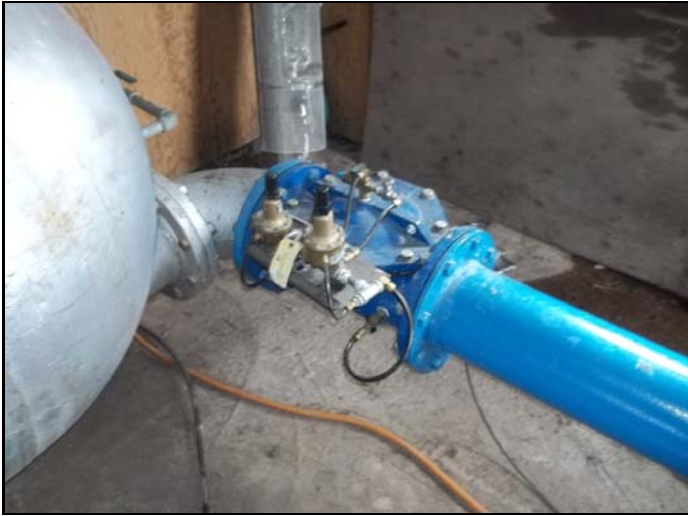
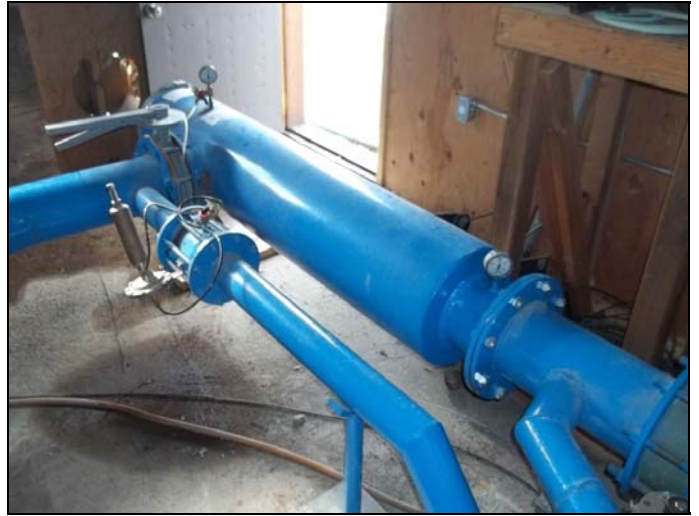
Comp #: 1790 Filter - Replace

The filter is in working condition. Research with the client reveals this component is nearing the end of its useful life. We recommend funding to replace this component approximately every 8 - 10 years. Remaining life based on current age and condition.

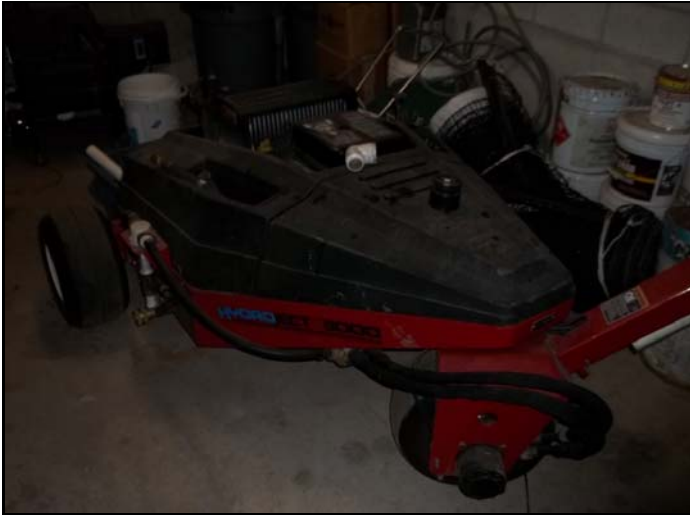
Comp #: 1801 Hydrojet Aerator - Replace

The hydrojet aerator is in working condition. Expect a useful life of 12 - 15 years from this component. Remaining life based on current age.

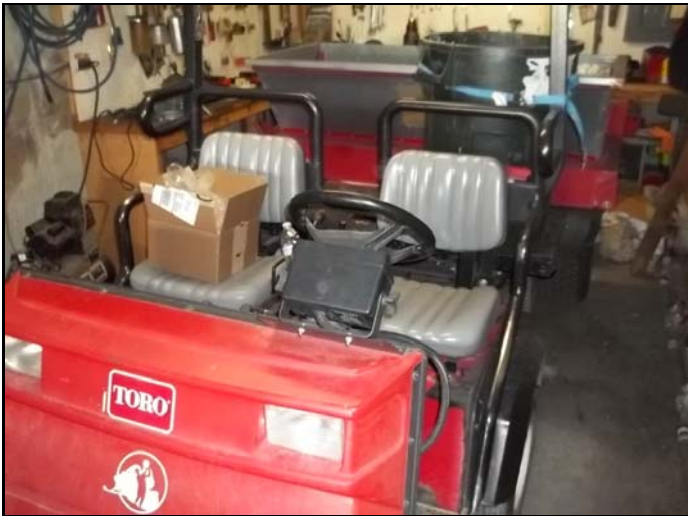
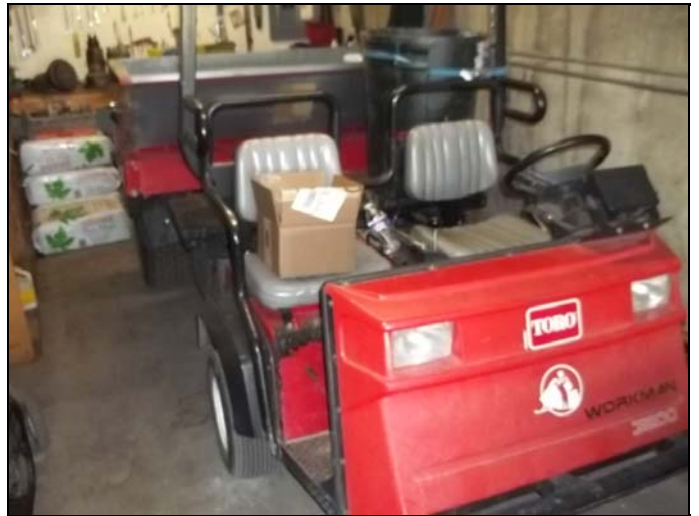
Comp #: 1801 Utility Vehicle - Replace

The utility vehicle is in working condition. Expect a useful life of 12 - 15 years from this component. Remaining life based on current age.

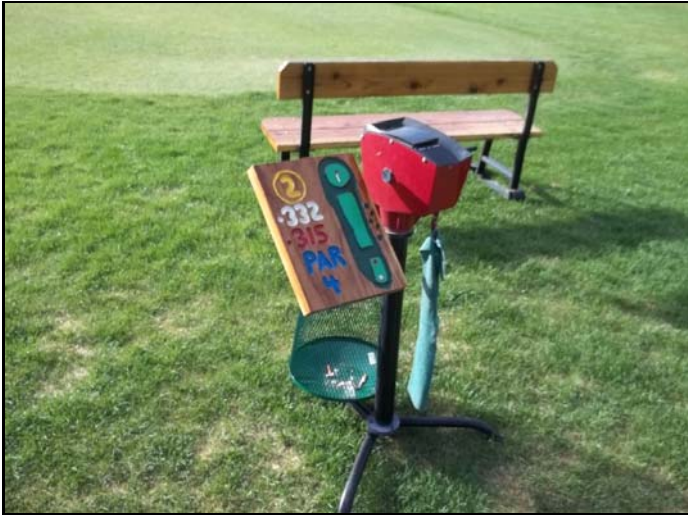
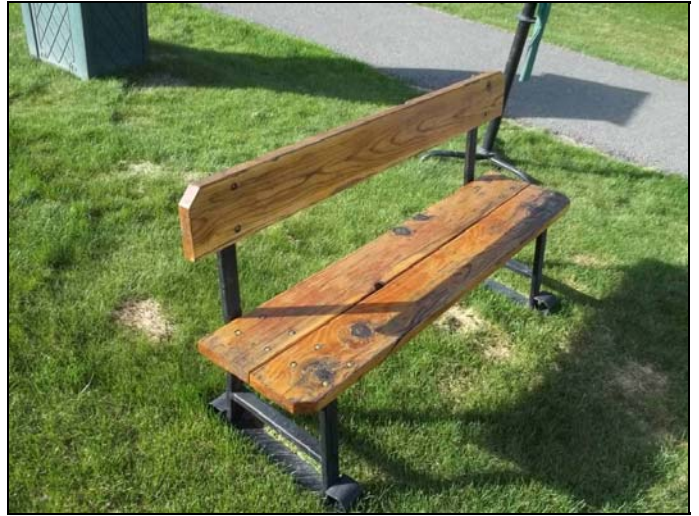
Comp #: 1802 Golf Course Signs & Furniture - Replace

The golf course signs and furniture are in good condition. Research with the client reveals the maintenance on this component is an operating expense and the replacement is a reserve expense. Expect a useful life of approximately 10 years from this component. Remaining life based on current age.

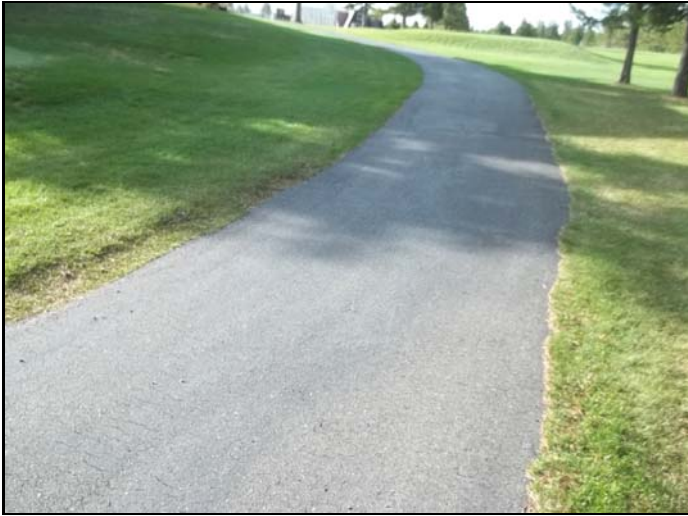
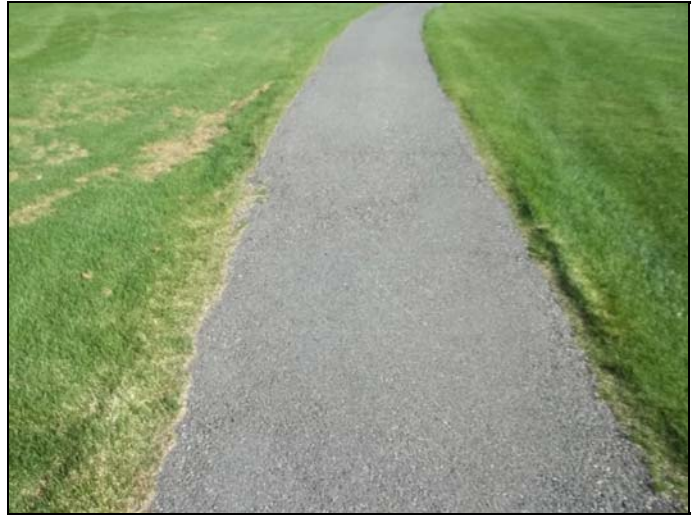
Comp #: 1803 Cart Path - Repair/Seal

The asphalt paths are in fair condition. Cracks, minor damage, uneven and settling sections were noted during the inspection. Typically this component will only require a seal coat as well as minor repairs approximately every 4 - 6 years. Remaining life based on current condition.

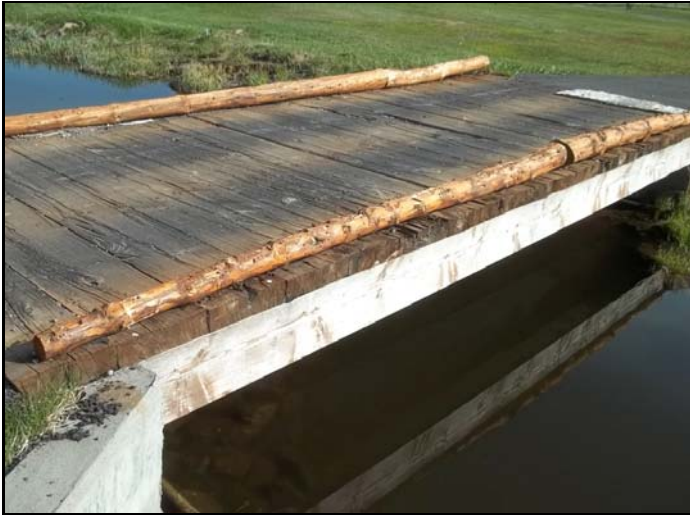
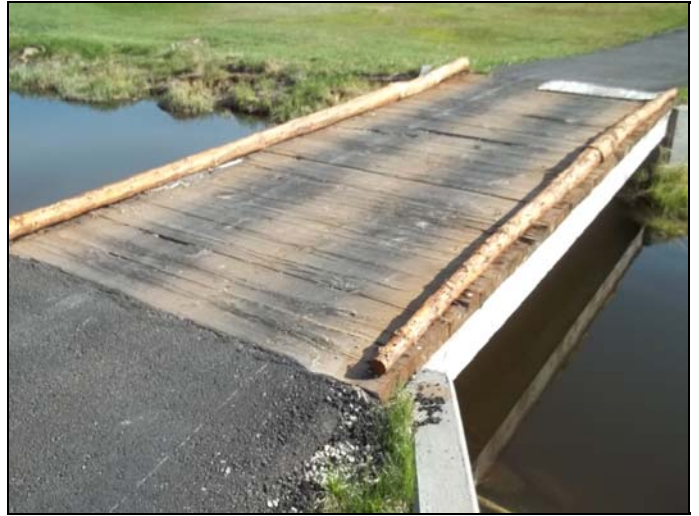
Comp #: 1806 Bridge - Rebuild/Replace

The bridge is in fair to poor condition. Research with the client reveals this bridge is in need of replacement. Damaged and rotten areas were noted at the time of inspection. We recommend funding to rebuild/replace this component approximately every 15 - 20 years to ensure appearance and function. Remaining life based on current condition.

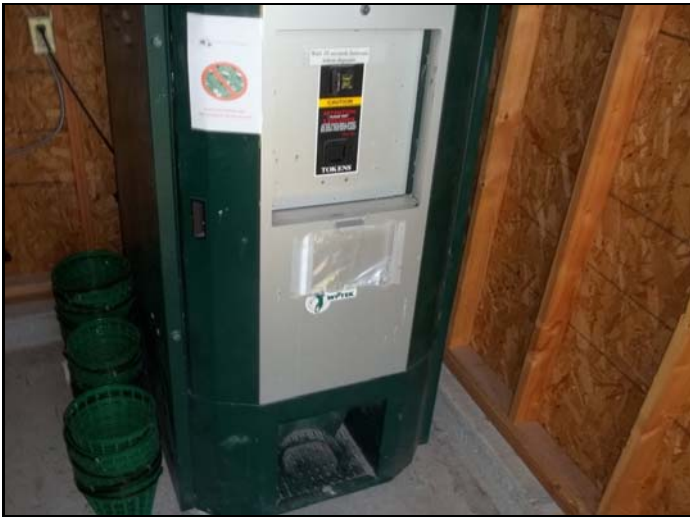
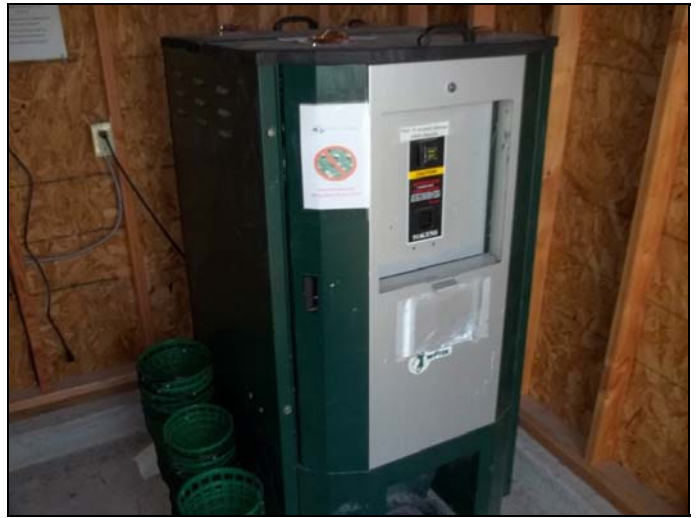
Comp #: 1890 Golf Ball Dispenser

The golf ball dispenser is in working condition. No problems were reported at the time of the inspection. We recommend funding to replace this component approximately every 10 - 12 years. Remaining life based on current age.

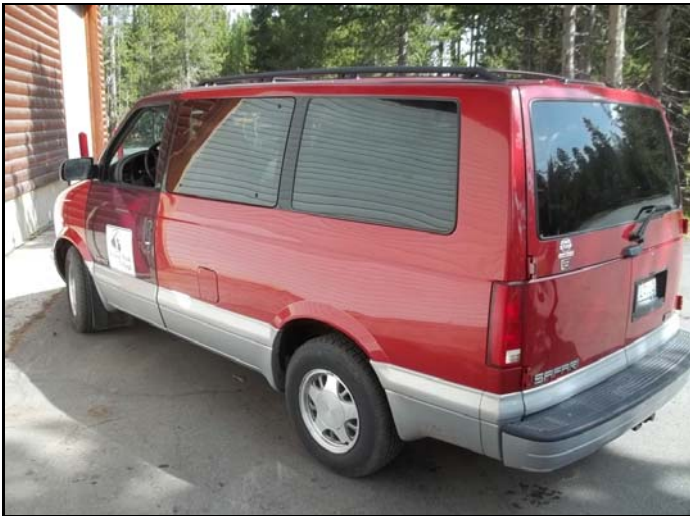
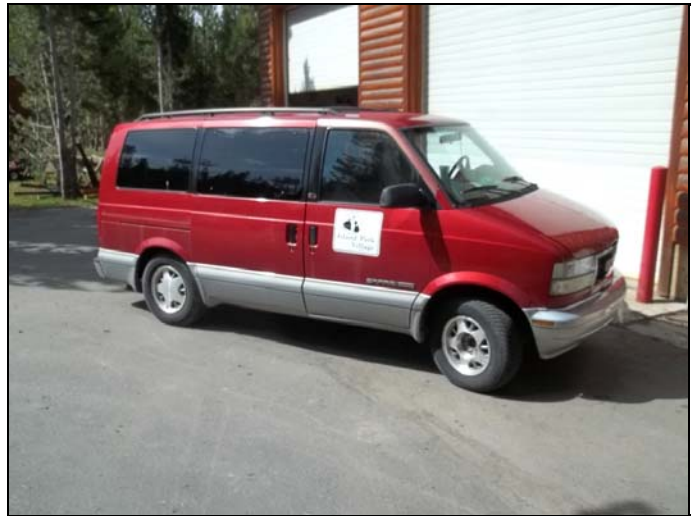
Comp #: 1901 Astrovan Red - Replace

The astrovan is in working condition. We recommend funding to replace this component approximately every 10 years. Perform regular maintenance as necessary as an operating expense to ensure full life from this component. Remaining life based on current age and condition.

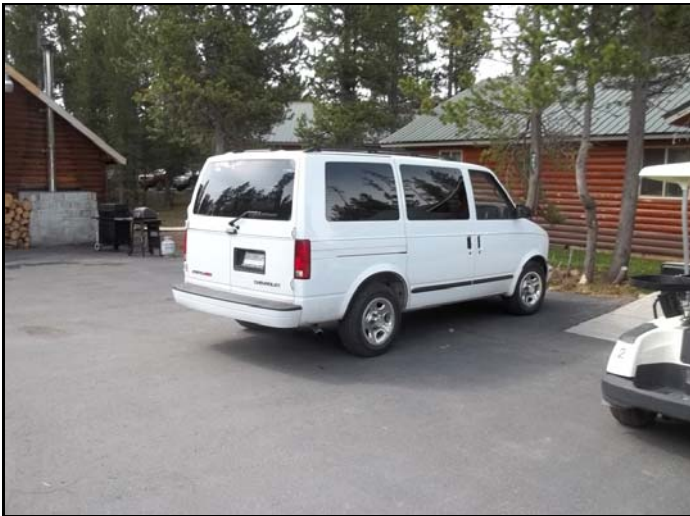
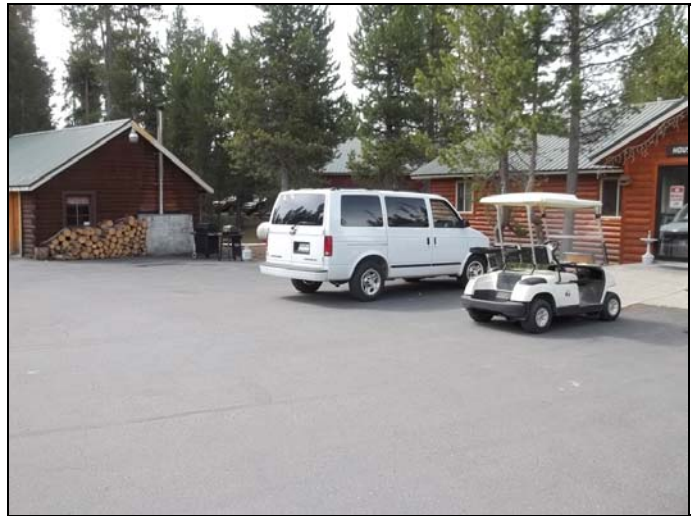
Comp #: 1901 Astrovan White - Replace

The astrovan is in working condition. This component has passed its useful life and so we recommend funding to replace it in the next few years. We recommend funding to replace this component approximately every 10 years. Perform regular maintenance as necessary as an operating expense to ensure full life from this component. Remaining life based on current age and condition.

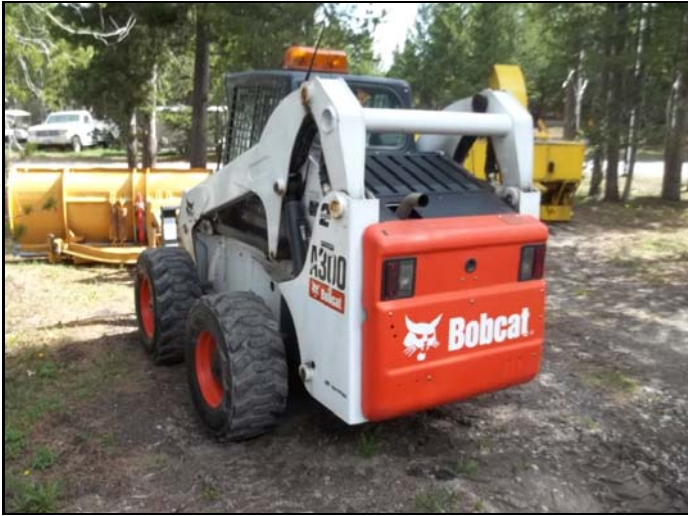
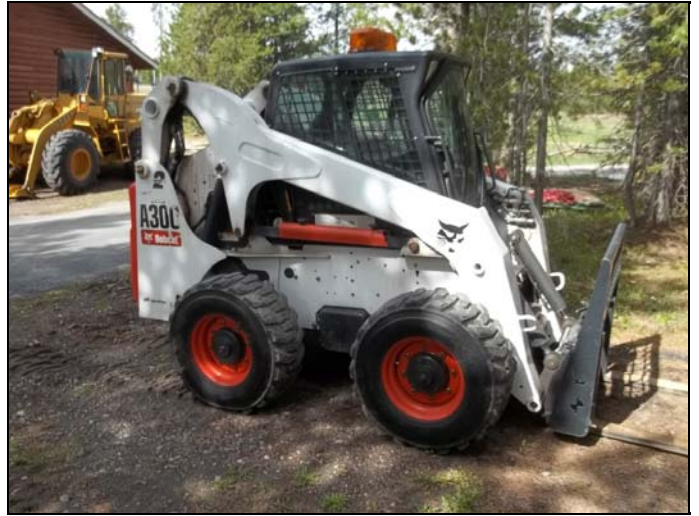
Comp #: 1901 Bobcat - Replace

The bobcat is in working condition. No problems were reported at the time of the inspection. We recommend funding to replace this component approximately every 12 - 15 years. Perform regular maintenance as necessary as an operating expense to ensure full life from this component. Remaining life based on current age.

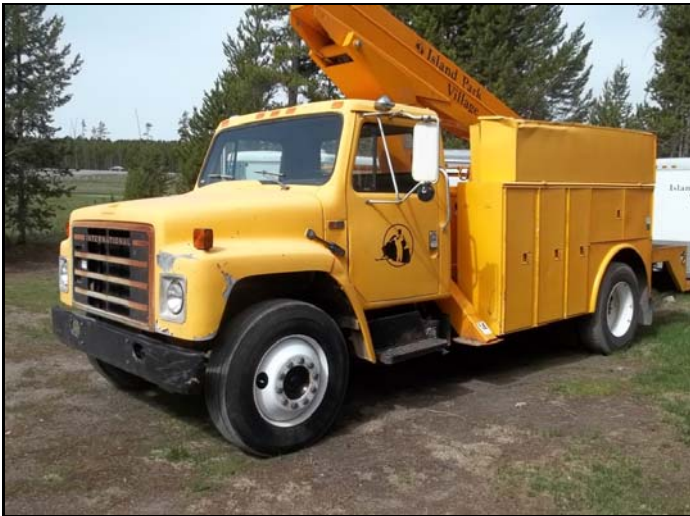
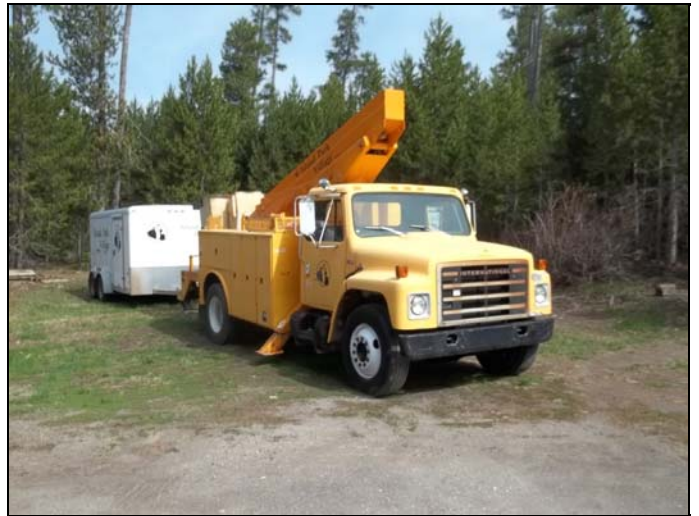
Comp #: 1901 Boom Truck - Replace

The boom truck is in working condition. This component has passed its useful life and so we recommend funding to replace it in the next few years. We recommend funding to replace this component approximately every 12 - 15 years. Perform regular maintenance as necessary as an operating expense to ensure full life from this component. Remaining life based on current age and condition.

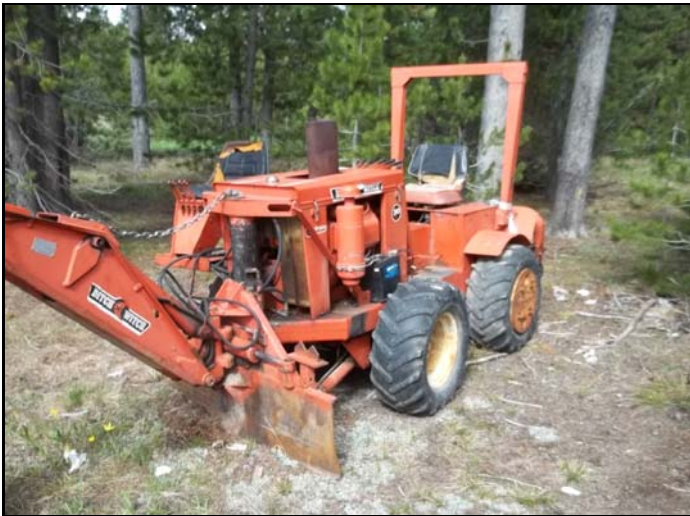
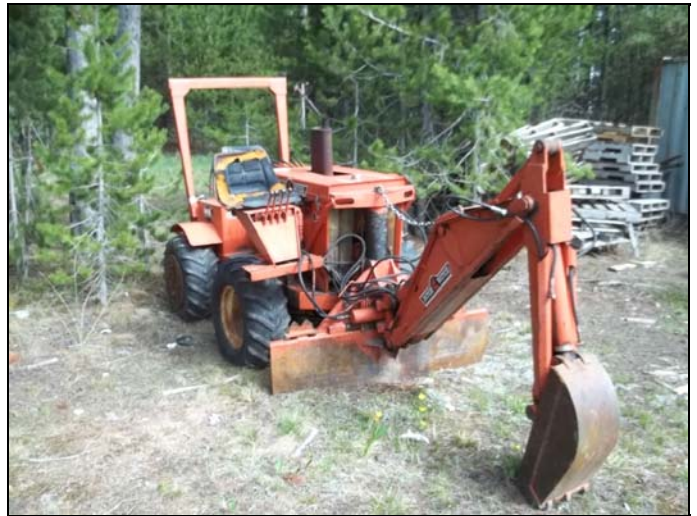
Comp #: 1901 Ditch Witch - Replace

The ditch witch is in working condition. This component has passed its useful life and so we recommend funding to replace it in the next few years. We recommend funding to replace this component approximately every 12 - 15 years. Perform regular maintenance as necessary as an operating expense to ensure full life from this component. Remaining life based on current age and condition.

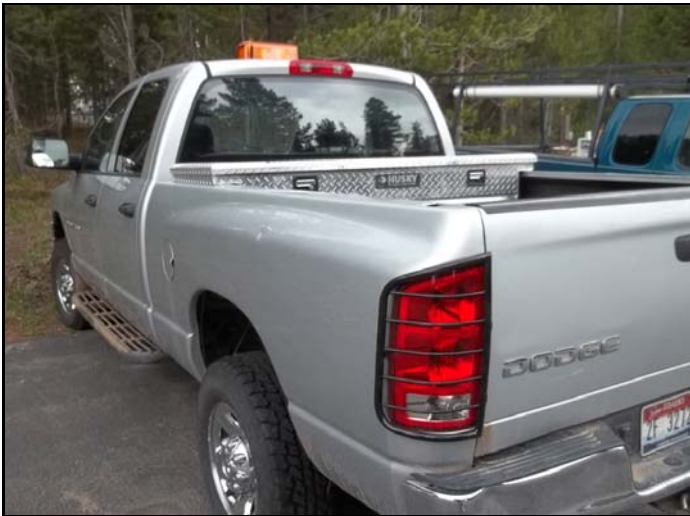
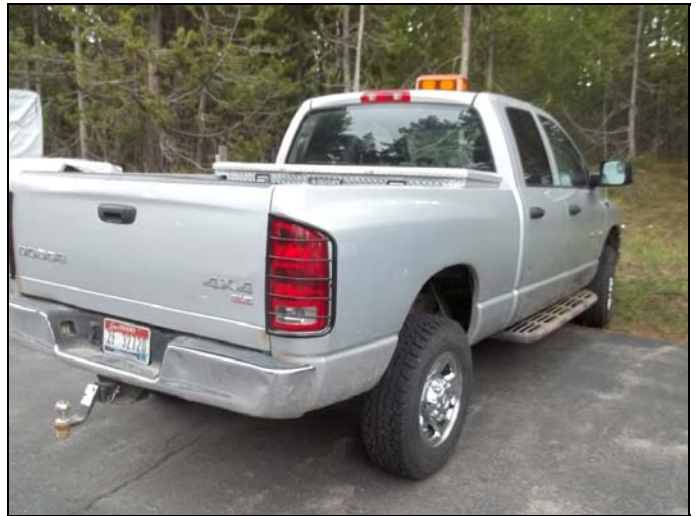
Comp #: 1901 Dodge 2500 Truck - Replace

The Dodge 2500 truck is in working condition. This component has passed its useful life and so we recommend funding to replace it in the next few years. We recommend funding to replace this component approximately every 10 years. Perform regular maintenance as necessary as an operating expense to ensure full life from this component. Remaining life based on current age and condition.

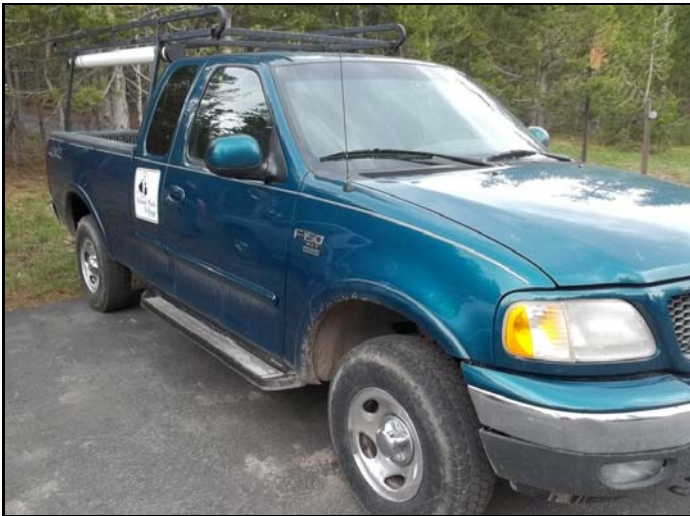
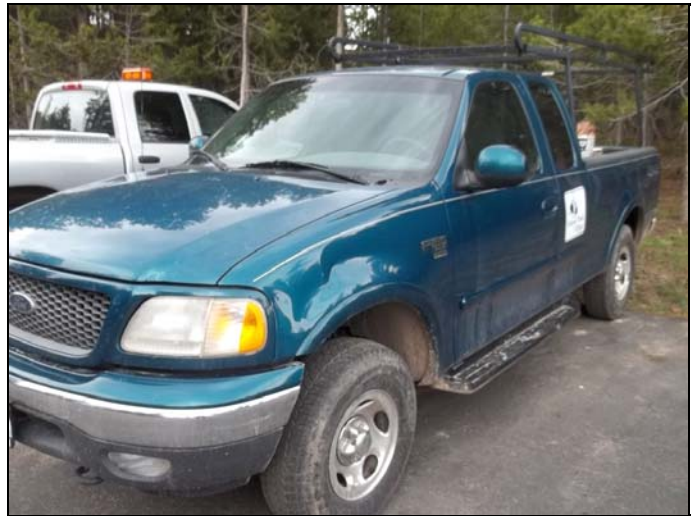
Comp #: 1901 F150 Truck - Replace

The F150 truck is in working condition. This component has passed its useful life and so we recommend funding to replace it in the next few years. We recommend funding to replace this component approximately every 10 years. Perform regular maintenance as necessary as an operating expense to ensure full life from this component. Remaining life based on current age and condition.

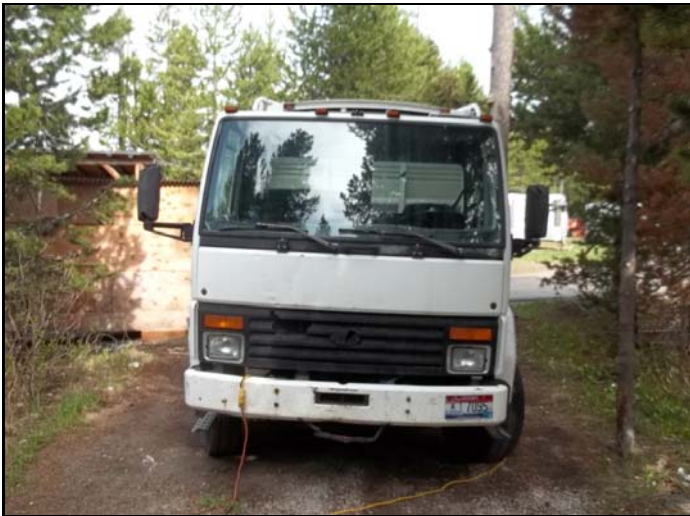
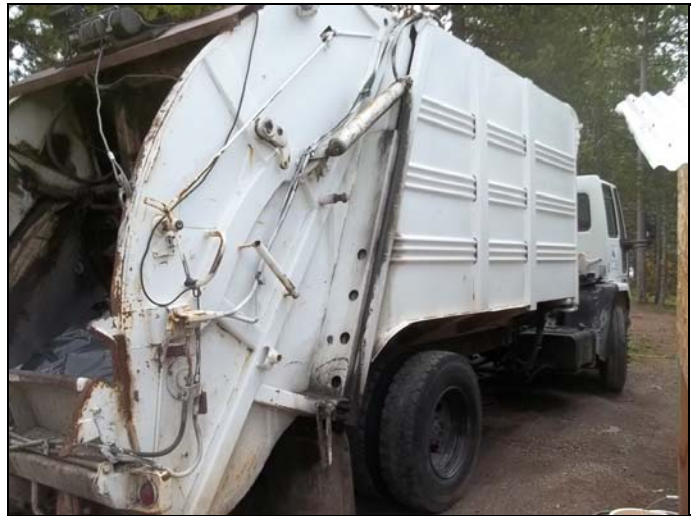
Comp #: 1901 Garbage Truck - Replace

The garbage truck is in working condition. This component has passed its useful life and so we recommend funding to replace it in the next few years. We recommend funding to replace this component approximately every 12 - 15 years. Perform regular maintenance as necessary as an operating expense to ensure full life from this component. Remaining life based on current age and condition.

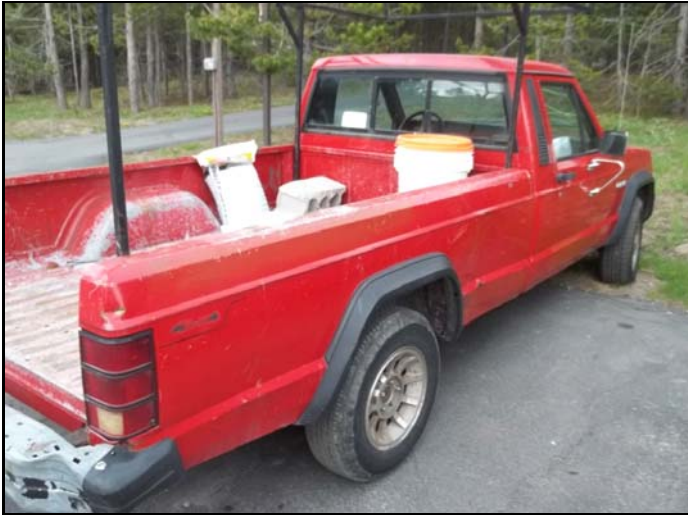
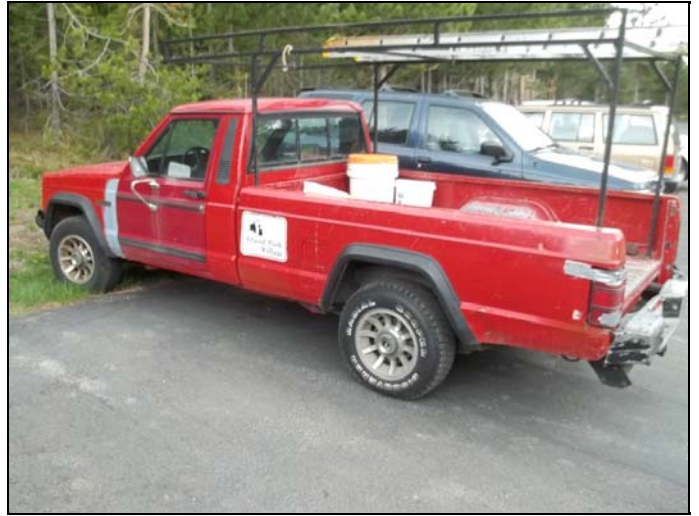
Comp #: 1901 Jeep Comanche - Replace

Research with the client reveals no plans to replace this component.
